Water saturation effects on the tensile strength of rocks

WATER SATURATION EFFECTS ON THE TENSILE STRENGTH OF ROCKS

A Final Year Project presented to the

Degree of Bachelor of Engineering

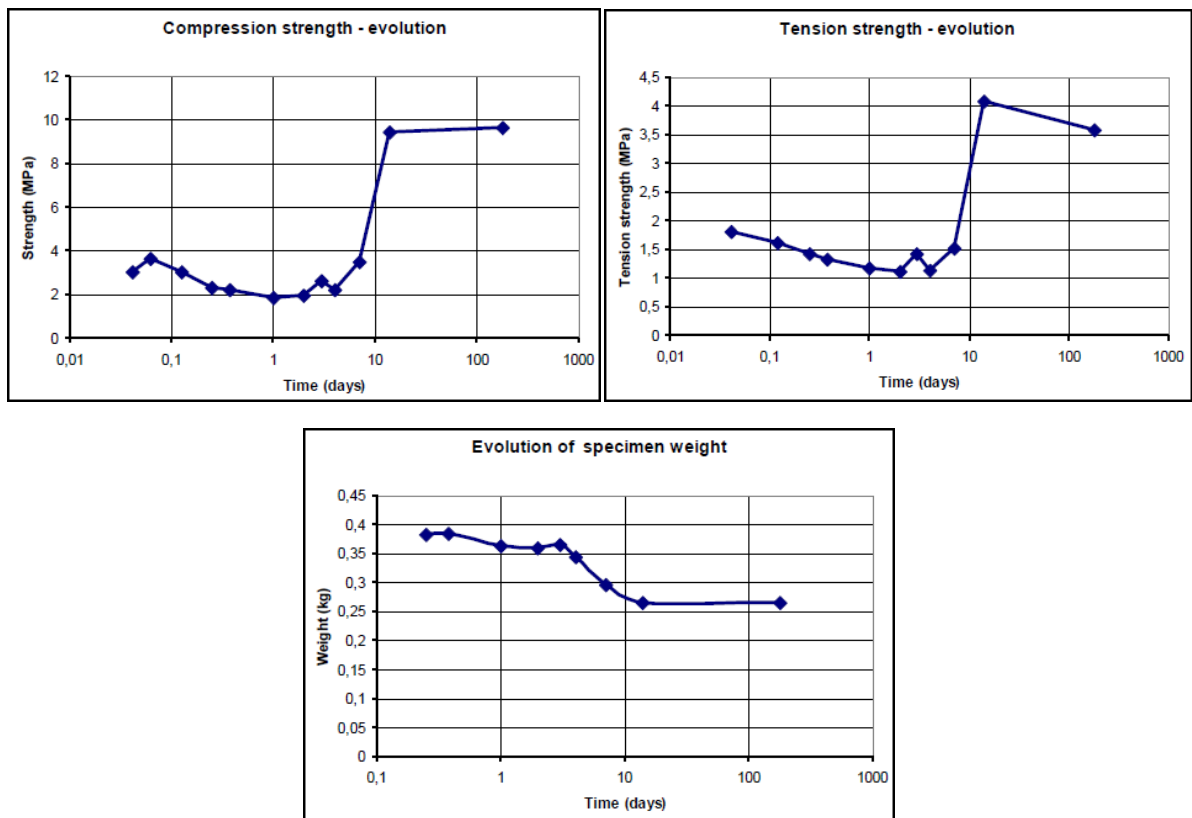
Figure 5 – Graphs showing the change in compressive strength, tensile strength and specimen weight with time after mixing. The period where the compressive strength and tensile strength increased rapidly corresponded to the period where the specimen is rapidly drying (Padevčt, Tesárek, & Plachý, 2011).

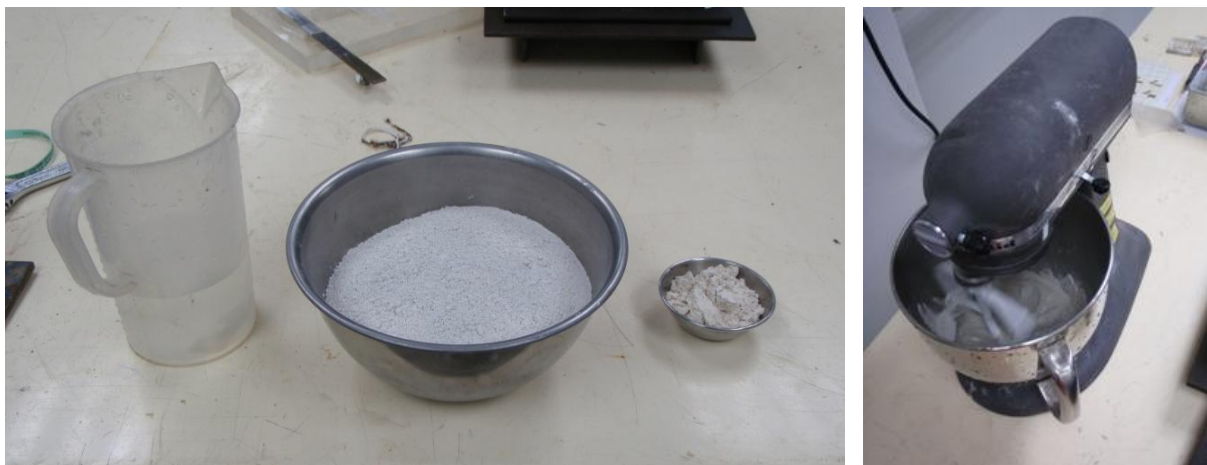
Each cylindrical gypsum samples were prepared using 350g of Hydrocal Gypsum cement (Gypsum powder), 4g of Celite, and 140g of water (Weight ratio of 87.5:1:35). The water and celite powder are first poured into the mixer and mixed for 20 seconds. The gypsum powder is then poured into the mixer and mixed for 2 minutes.

Figure 6 - (Left) 140ml of water, 350g of Gypsum powder and 4g of celite;
(Right) Mixing the Gypsum paste in the mixer

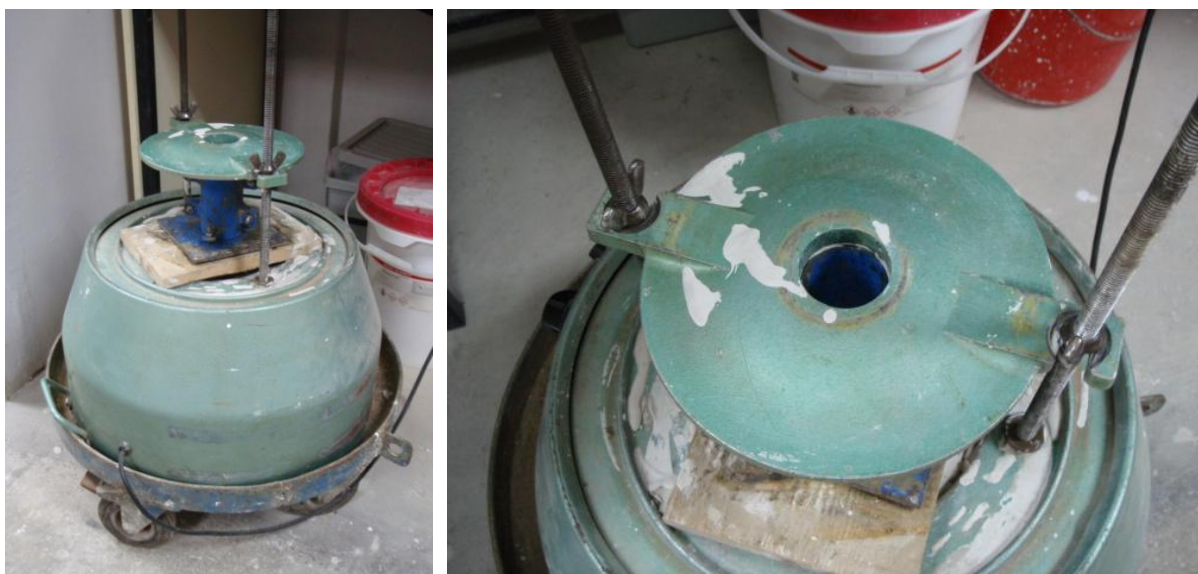
With the cylindrical mold (50mm diameter; 120mm height) secured to a vibrating machine, the machine is switched on and the gypsum paste is poured into the mold through the opening in the cap of the vibrating machine. The gypsum paste in the mold is vibrated for about 5 minutes to remove as much trapped air from the paste as possible.

Figure 7 – (Left) The cylindrical mold secured to a vibrating machine where it is vibrated;
(Right) The opening on the cap of the vibrating machine through which the gypsum paste was poured in the mold

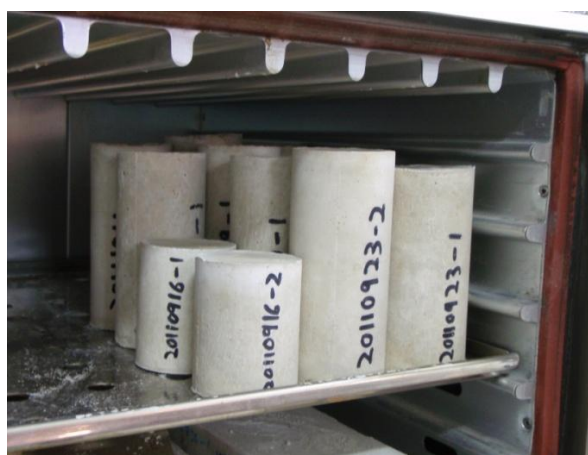
Figure 9 - The samples are labelled and kept in an oven at 40°C

In order to determine the amount of time required for the sample to be sufficiently dry and hardened, the mass of the sample is recorded on a daily basis until it has dropped to a nearly constant value. From the trial experiments conducted, the mass of the samples dropped to a nearly constant value after about 10 days. Hence, all the samples prepared will be kept in the oven for at least 10 days.

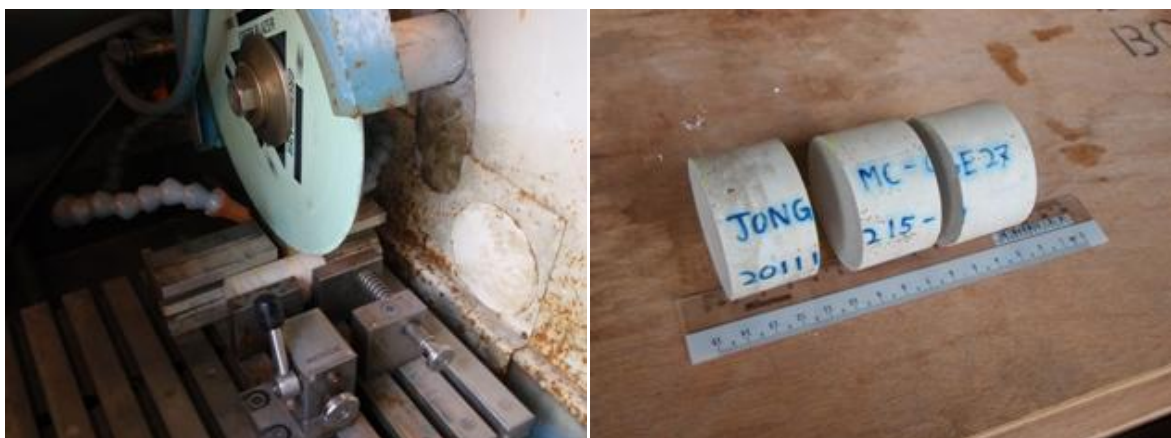
The cylindrical sample is then cut into disks of 30mm thickness and the specimens are stored in the oven until they're required for the experiment.

Figure 11 – The cylindrical sample is cut into disks of 30mm thickness

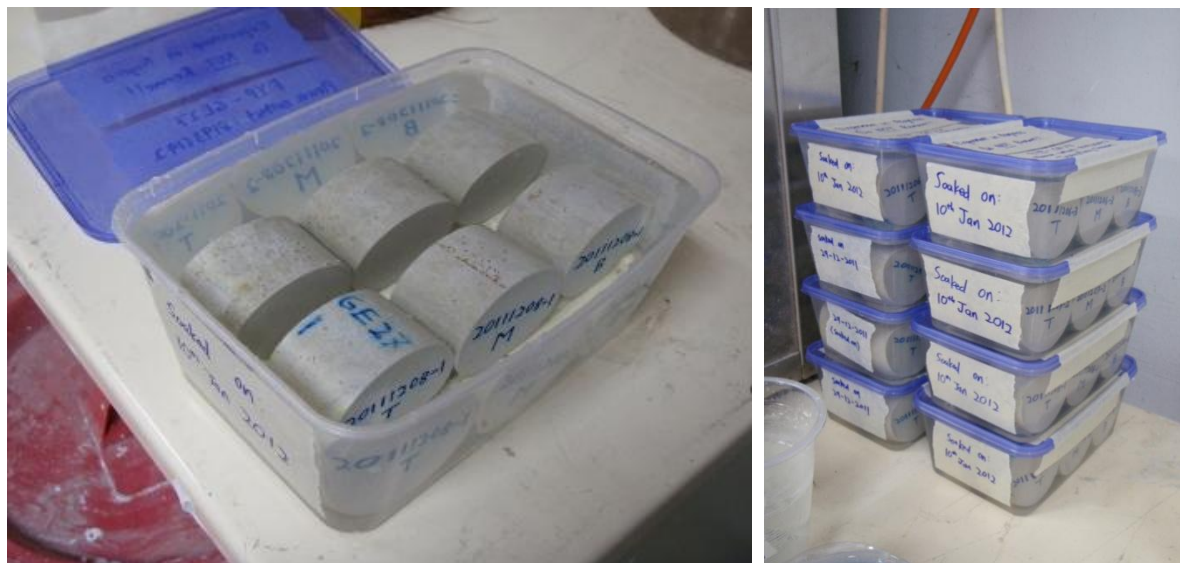
After the immersion time required has been determined from the trial experiments, the specimens for the subsequent actual experiments would be immersed in water for 1 week, 3 weeks, and 12 weeks to achieve their respective level of saturation. However, due to time constraint, the specimens can only be immersed for a maximum duration of 10 weeks. The Brazilian Tensile test will be conducted on the specimens once they're taken out from the water.

Figure 14 - Specimens for the subsequent actual experiments were immersed in water for 1 week, 3 weeks, and 10 weeks to achieve their respective level of saturation

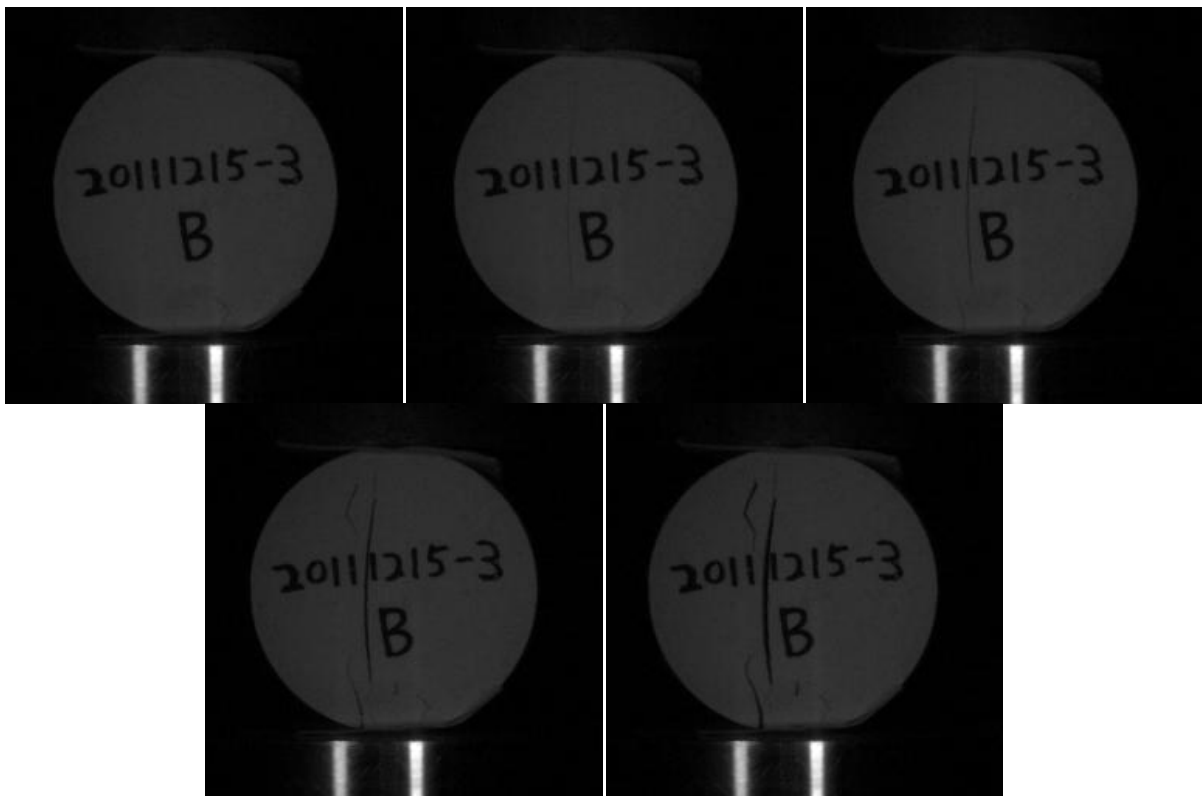
Figure 19 – Selected frames from a high-speed footage showing the primary crack initiating at the centre of the specimen followed by several secondary cracks

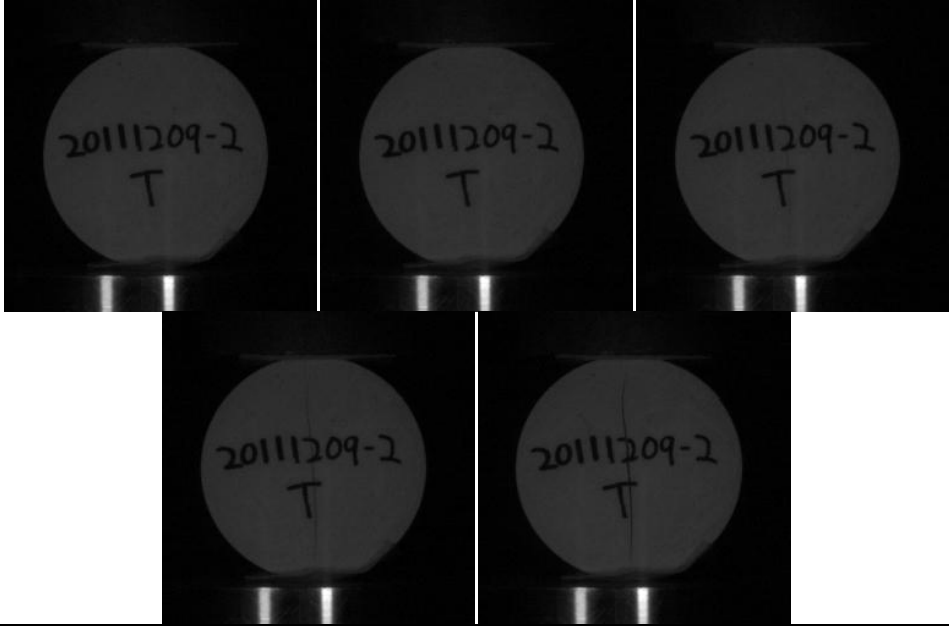
<p>High speed footage shows the primary crack initiated at the centre of the specimen. The crack later lengthened to form a diametrical crack.</p>
<p align="center">The specimen after the test</p>

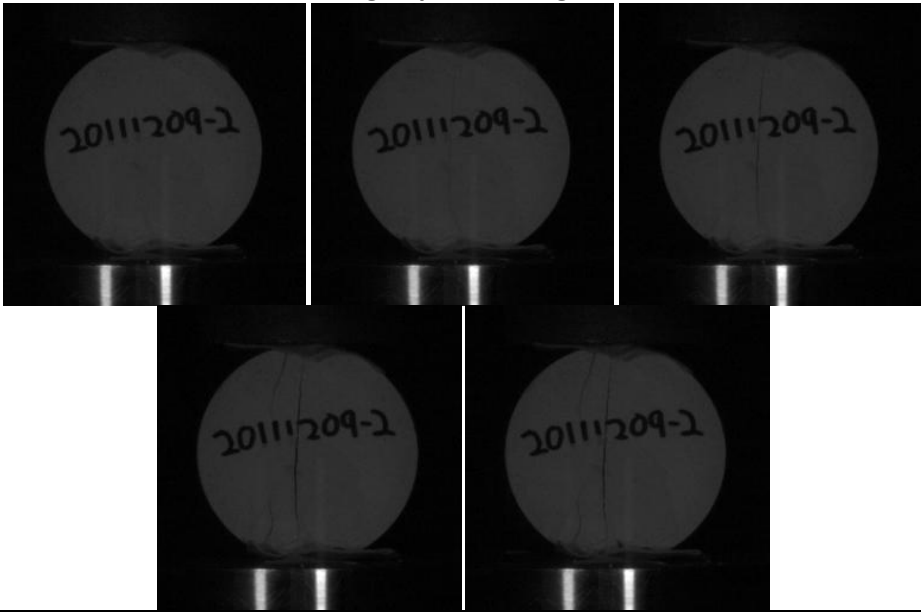
<p>Surface spalling has occurred before the first diametrical crack was initiated. Secondary cracks occurred soon after the first diametrical crack.</p>
<p>Specimen after the test</p>

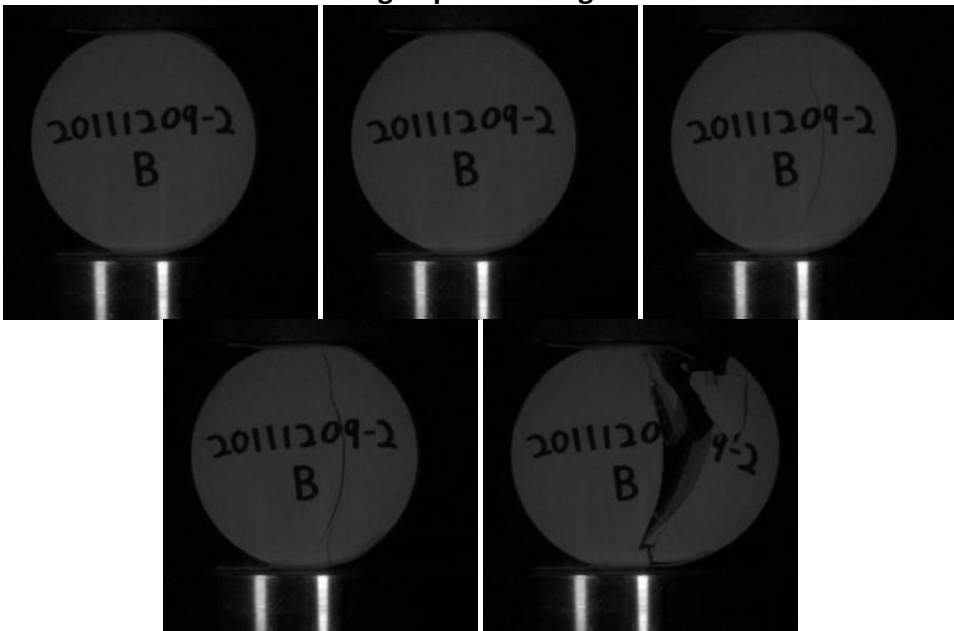
<p>The crack initiated slightly off-centred in the specimen.</p> <p>The crack lengthened and broke through the top and bottom of the specimen causing the specimen to break apart.</p>
<p>Specimen after the test</p>

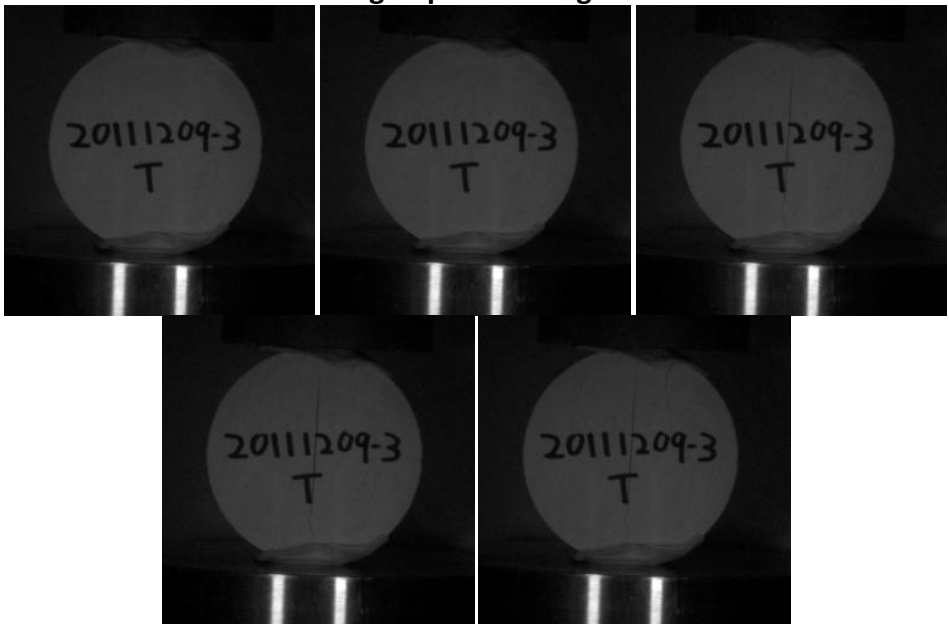
<p>The primary crack initiated at the centre of the specimen before it lengthened and widened. Secondary cracks developed shortly after the primary diametrical crack.</p>
<p style="text-align: center;">Specimen after the test</p>

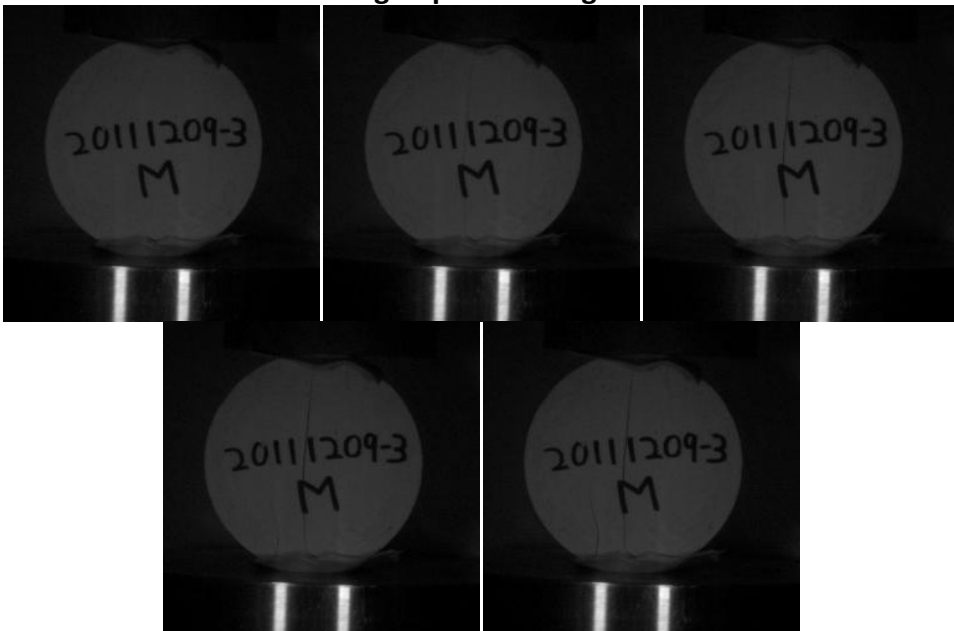
<p>The primary crack initiated at the centre of the specimen before it lengthened and widened. Secondary cracks developed shortly after the primary diametrical crack.</p>
<p align="center">Specimen after the test</p>

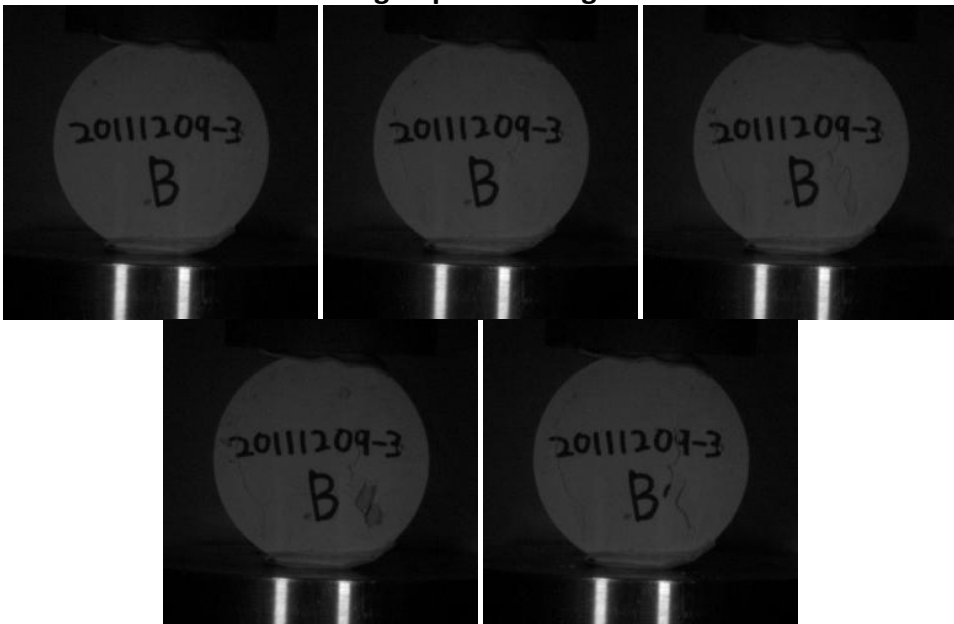
<p>Surface spalling of the specimen occurred and prevented the high-speed camera from capturing the initiation of the primary crack.</p>
<p>Specimen after the test</p>

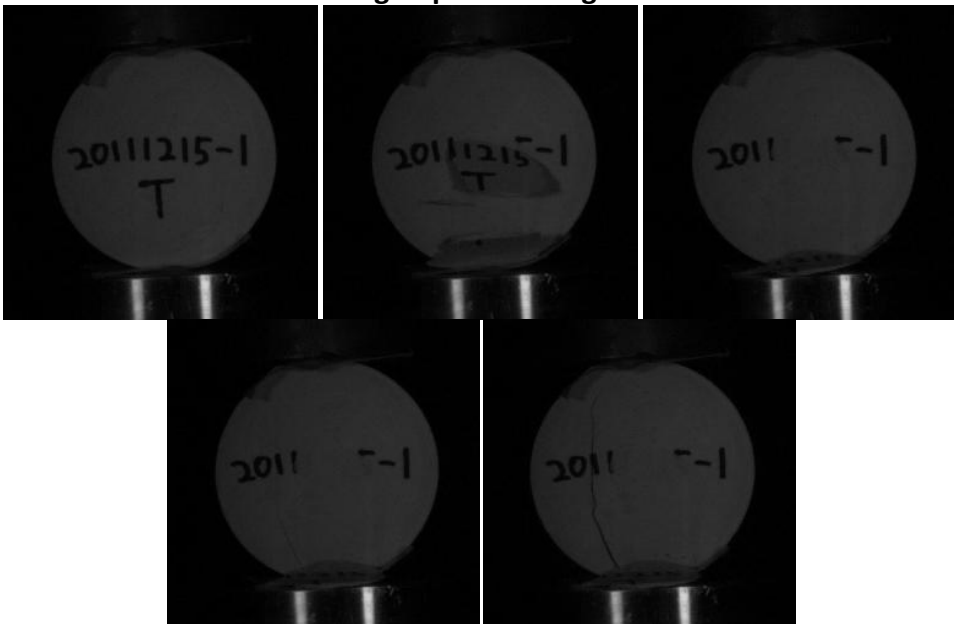
<p>Surface spalling firstly occurred. The primary crack was then initiated at the bottom of the specimen and the crack propagated into the specimen along pre-existing weakness in the specimen.</p>
<p>Specimen after the test</p>

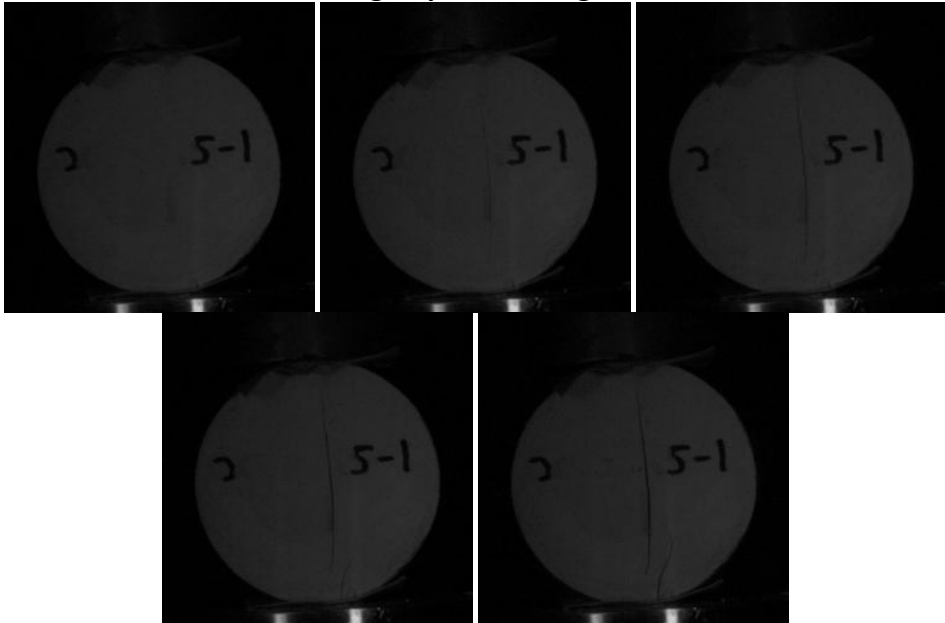
<p>Surface spalling has occurred before the first diametrical crack was initiated at the centre of the specimen. Shortly afterwards, a secondary crack was formed near the bottom of the specimen.</p>
<p style="text-align: center;">Specimen after the test</p>

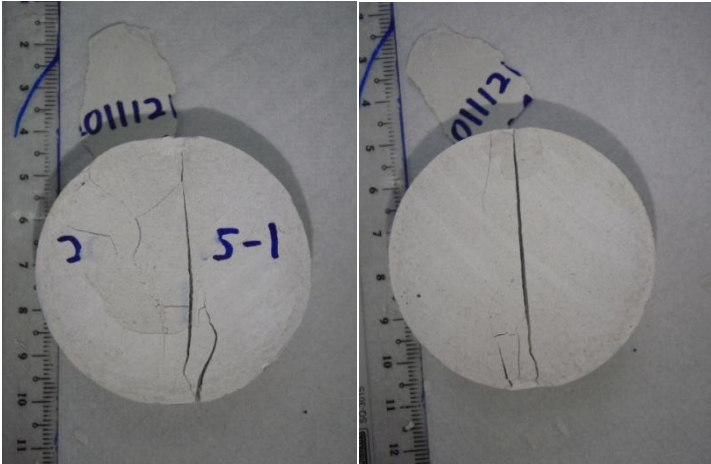
Specimen No: 20111215-1B

<p>Note: Results from this specimen was discarded due to surface spalling occurring before the first diametrical crack.</p>

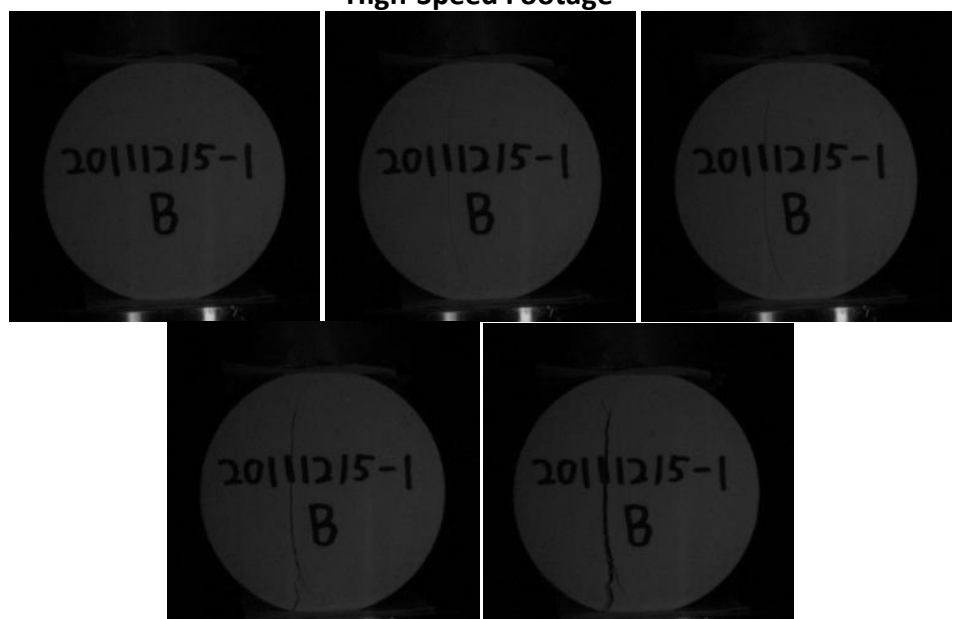
<p>The primary crack was initiated at the centre of the specimen. Then, a secondary crack was formed from the bottom of the specimen and propagated into the primary crack causing the specimen to break apart.</p>
<p>Specimen after the test</p>

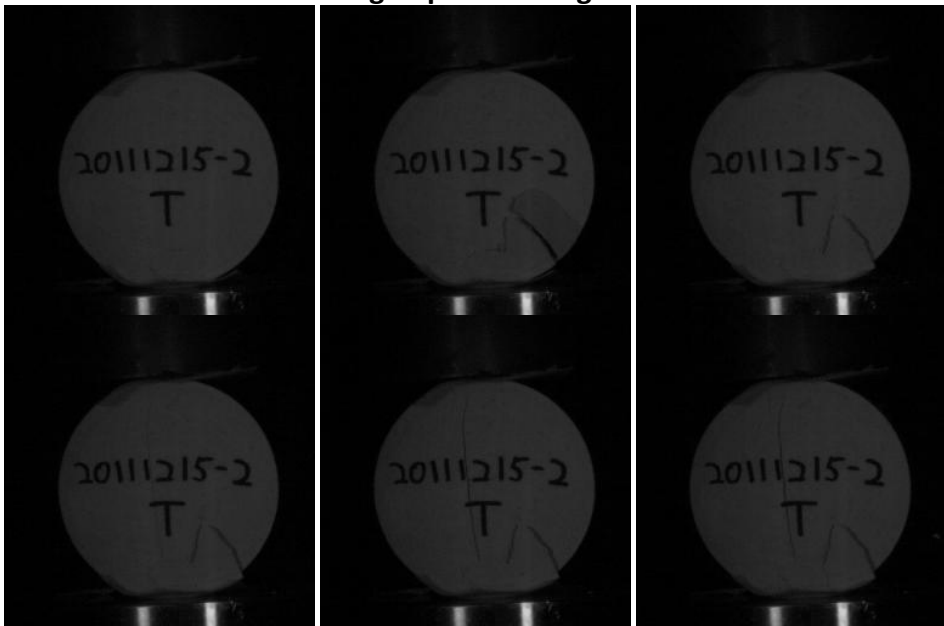
<p>Minor surface spalling firstly occurred near the bottom-right of the specimen. Then, the diametrical crack was initiated at the centre of the specimen away from the spalled surface.</p>
<p style="text-align: center;">Specimen after the test</p>

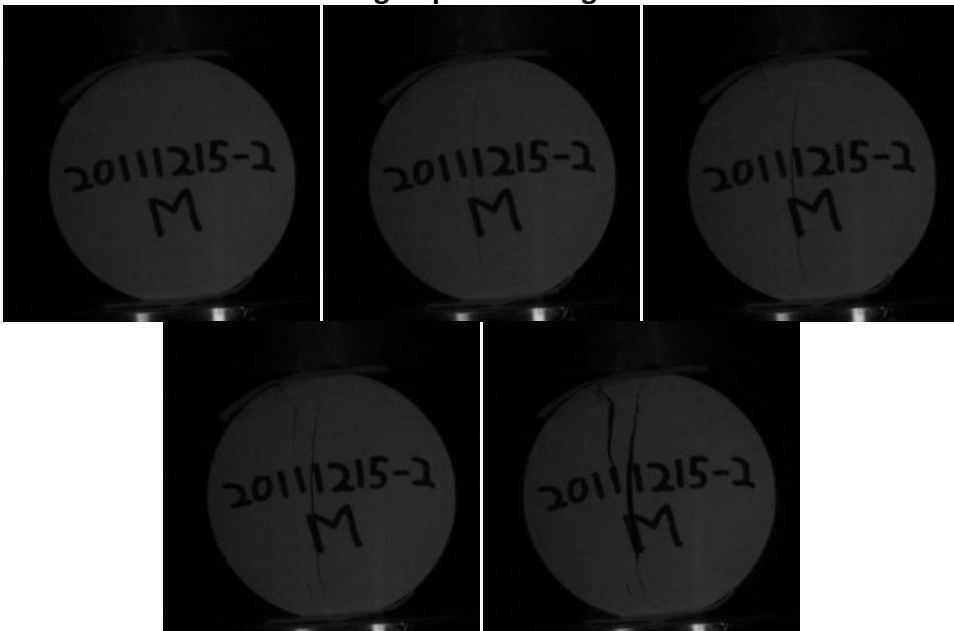
<p>The primary crack was initiated at the centre of the specimen and lengthened to form a diametrical crack. Secondary cracks were formed shortly afterwards at the top of the specimen.</p>
<p align="center">Specimen after the test</p>

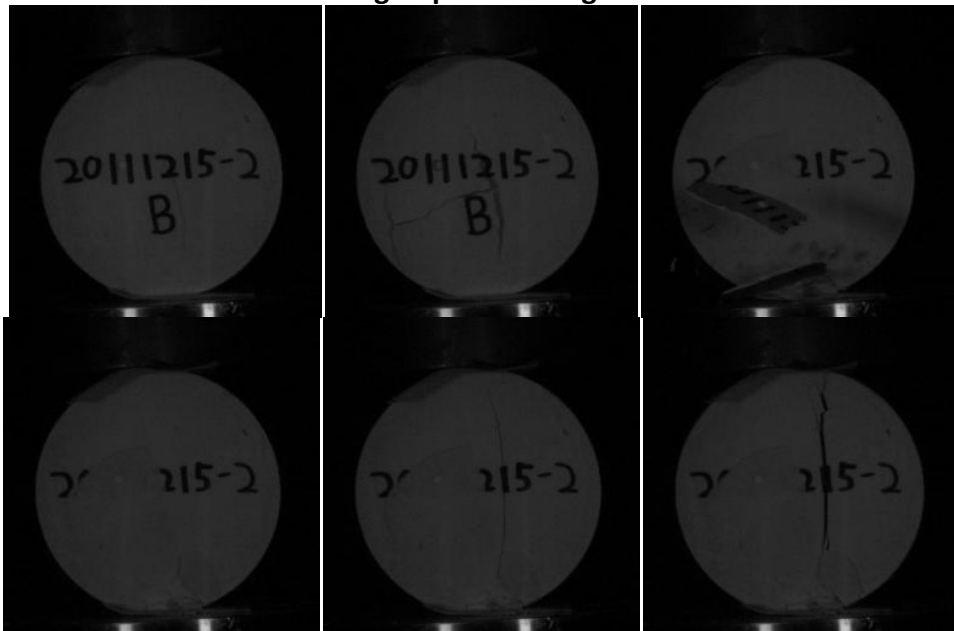
<p>Surface spalling firstly occurred on the centre-left of the specimen. The primary crack was then initiated at the centre of the specimen away from the spalled surface.</p>
<p>Specimen after the test</p>

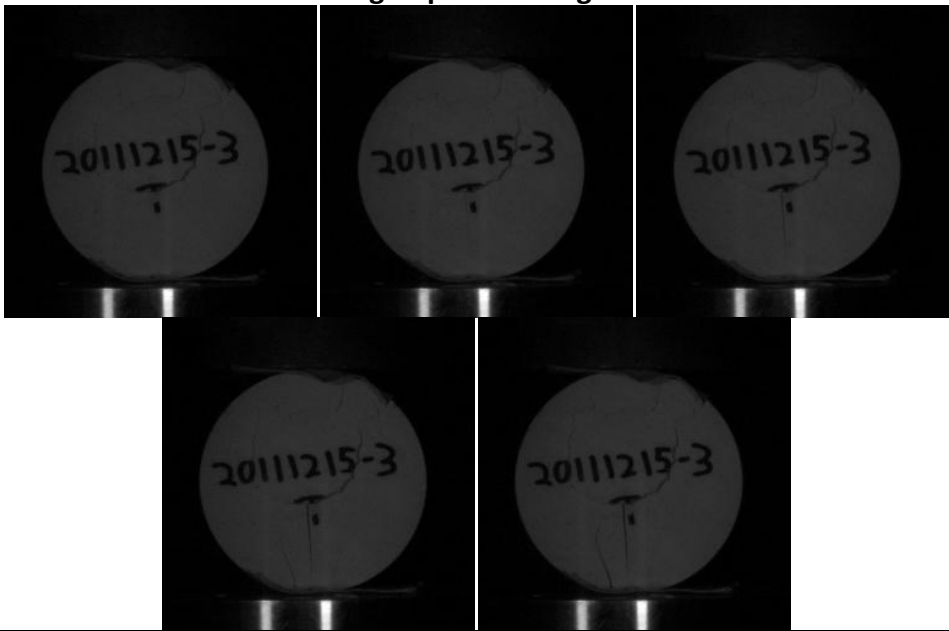
<p>Surface spalling of the specimen occurred and prevented the high-speed camera from fully capturing the initiation of the primary crack.</p>
<p>Specimen after the test</p>

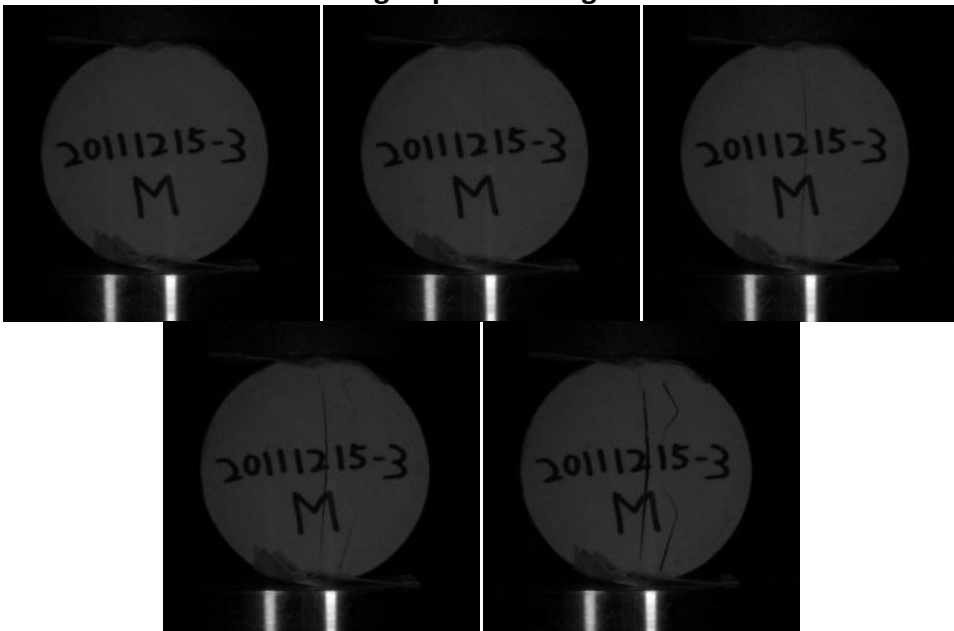
<p>The primary crack was initiated at the centre of the specimen and lengthened to form a diametrical crack. Secondary cracks was formed shortly afterwards from the top and bottom of the specimen.</p>
<p style="text-align: center;">Specimen after the test</p>

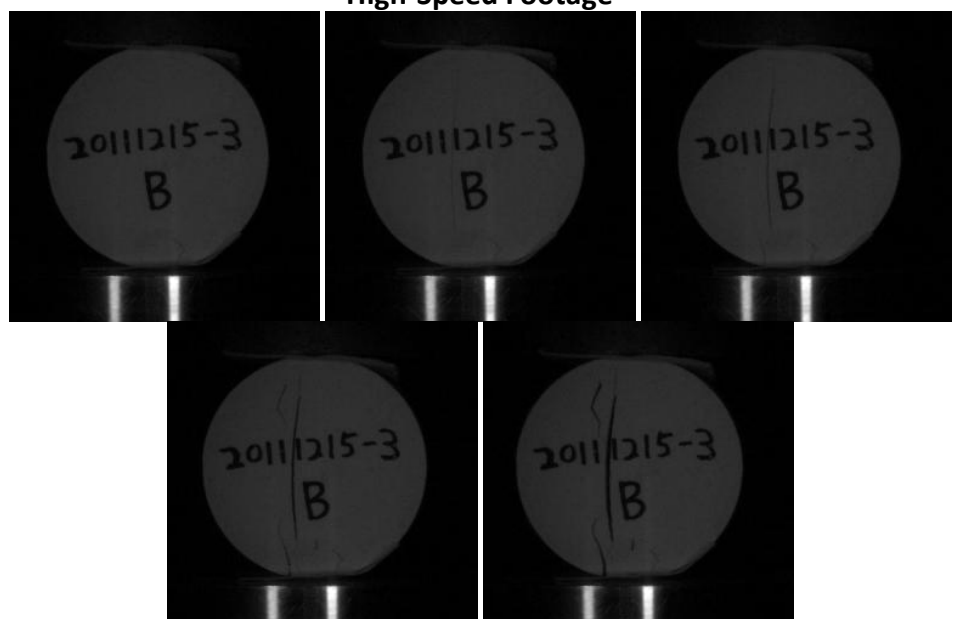
<p>The primary crack was initiated at the centre of the specimen and lengthened to form a diametrical crack. Secondary cracks was formed shortly afterwards from the top and bottom of the specimen.</p>
<p>Specimen after the test</p>

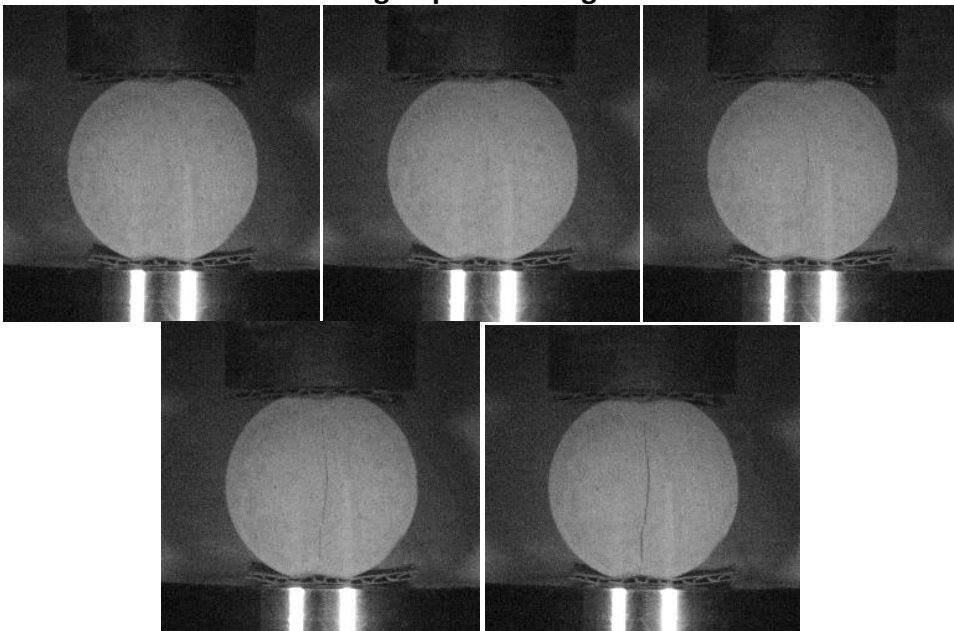
<p>High speed footage shows the primary crack initiated at the centre of the specimen. The crack later lengthened to form a diametrical crack.</p>
<p style="text-align: center;">Specimen after the test</p>

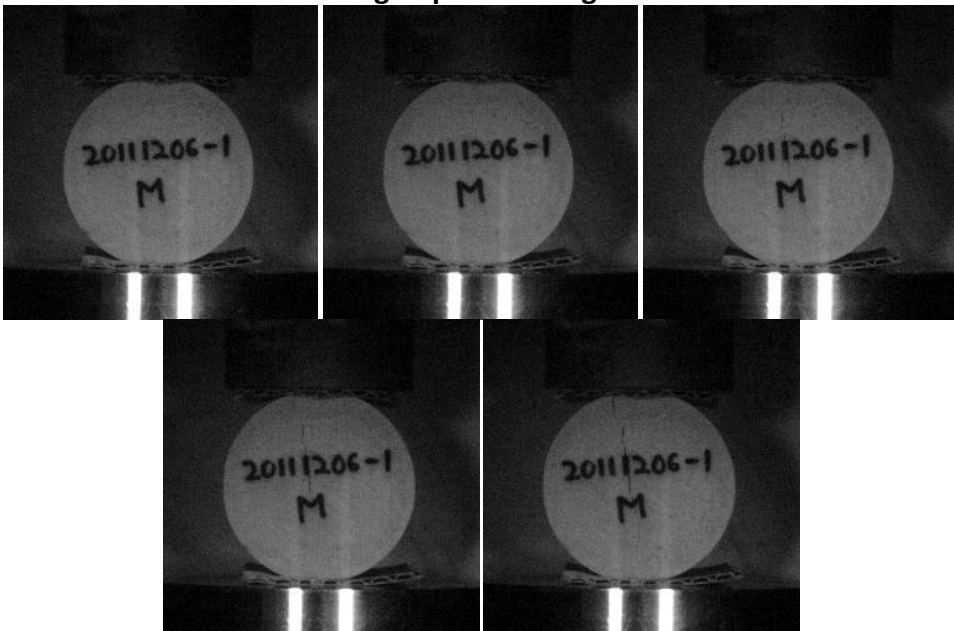
<p>The primary crack initiated at the centre of the specimen and lengthened to the top and bottom of the specimen. The primary crack became connected to a secondary crack near the top of the specimen.</p>
<p style="text-align: center;">Specimen after the test</p>

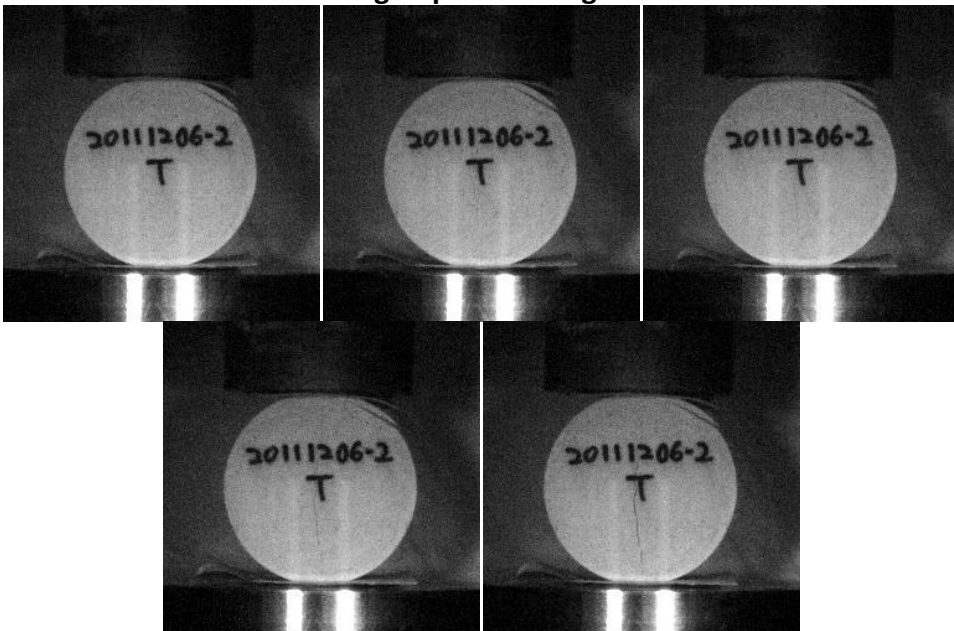
<p>A minor pre-existing crack already existed near the top-right of the specimen but was considered to have little or no influence on the test. The primary crack was initiated at the centre of the specimen before it lengthened to form a diametrical crack.</p>
<p style="text-align: center;">Specimen after the test</p>

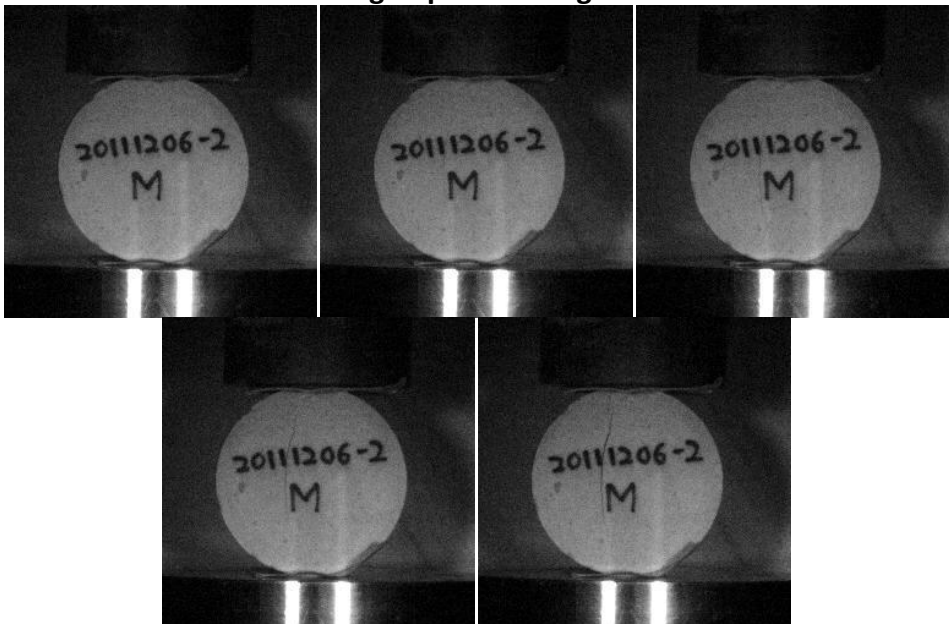
<p>The primary crack initiated at the centre of the specimen and lengthened to the top and bottom of the specimen. The primary crack became connected to a secondary crack near the top of the specimen.</p>
<p style="text-align: center;">Specimen after the test</p>

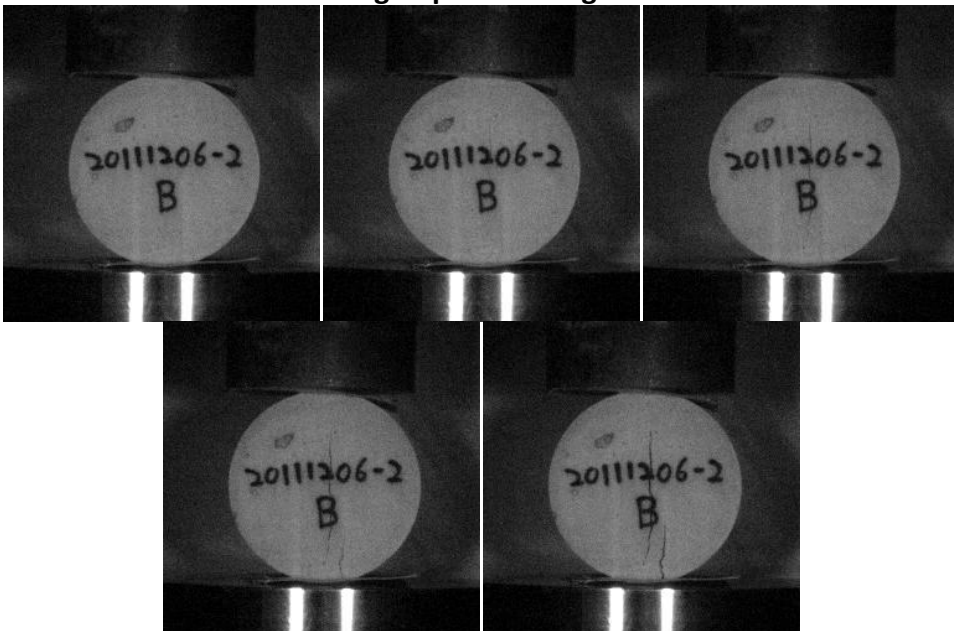
<p>The primary crack initiated at the centre of the specimen and propagated towards the top and bottom of the specimen. A secondary crack was then formed at the bottom of the specimen.</p>
<p>Specimen after the test</p>

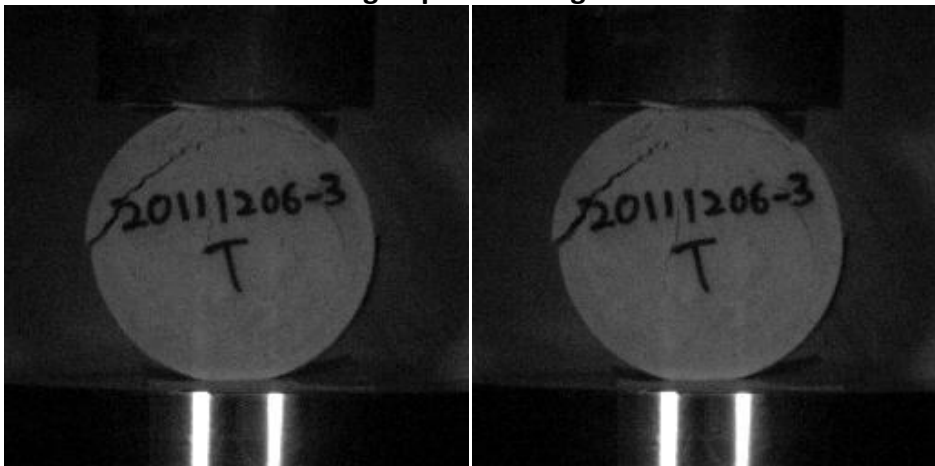
Specimen No: 20111206-3T (Discarded)

<p><u>Immersion Time</u> 1 week</p> <p><u>Diameter</u> 50mm</p> <p><u>Thickness</u> 30.2mm</p> <p><u>Max Load</u> 4.94278kN</p> <p><u>Tensile Strength</u> 2.084MPa</p> <p><u>Stiffness</u> 4.1466kN/mm</p>
<p>High-Speed Footage</p>

<p>A sideways crack was firstly initiated along pre-existing flaws near the top of the specimen.</p>
<p>Specimen after the test</p>

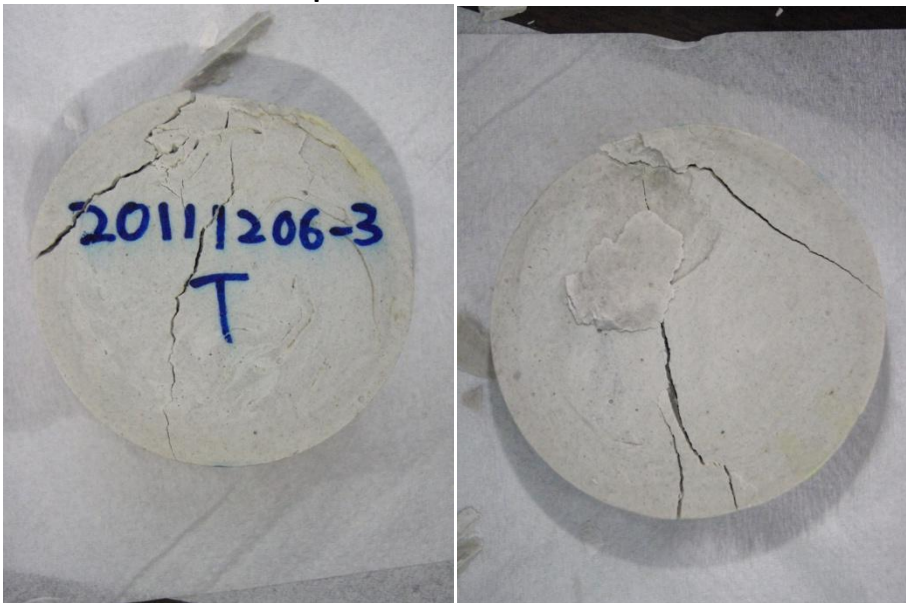
<p>Many other cracks were also formed later along pre-existing flaws in the specimen. The test result of this specimen was discarded as the specimen did not fail as required for a Brazilian Tensile test.</p>

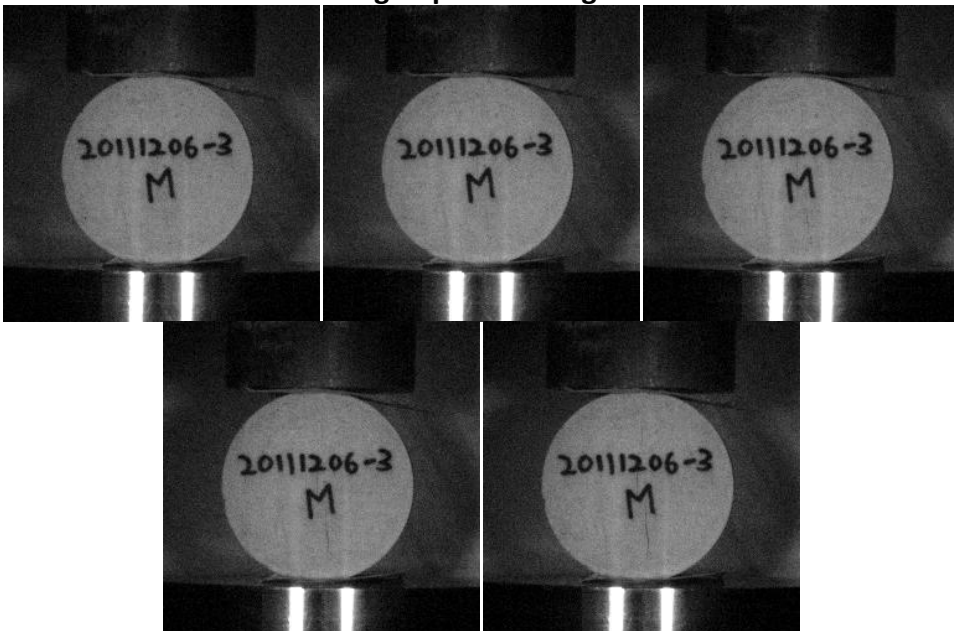
<p>The primary crack initiated at the centre of the specimen and propagated towards the top and bottom of the specimen.</p>
<p align="center">Specimen after the test</p>

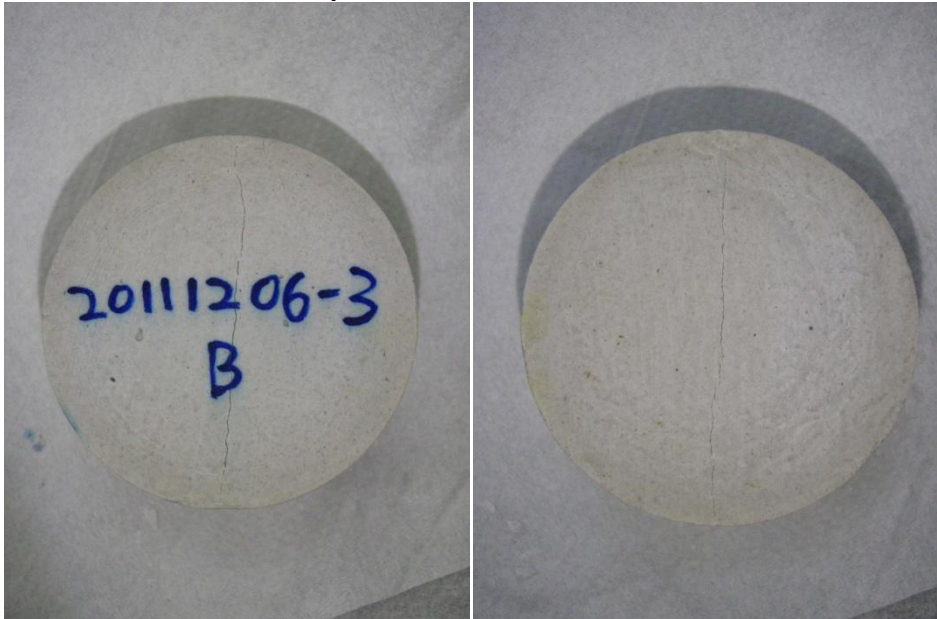
<p>Physical inspection of the specimen showed that the primary crack did not break through the top and bottom of the specimen. Hence, it can be deduced that the crack initiated at the centre of the specimen and tensile failure has occurred.</p>

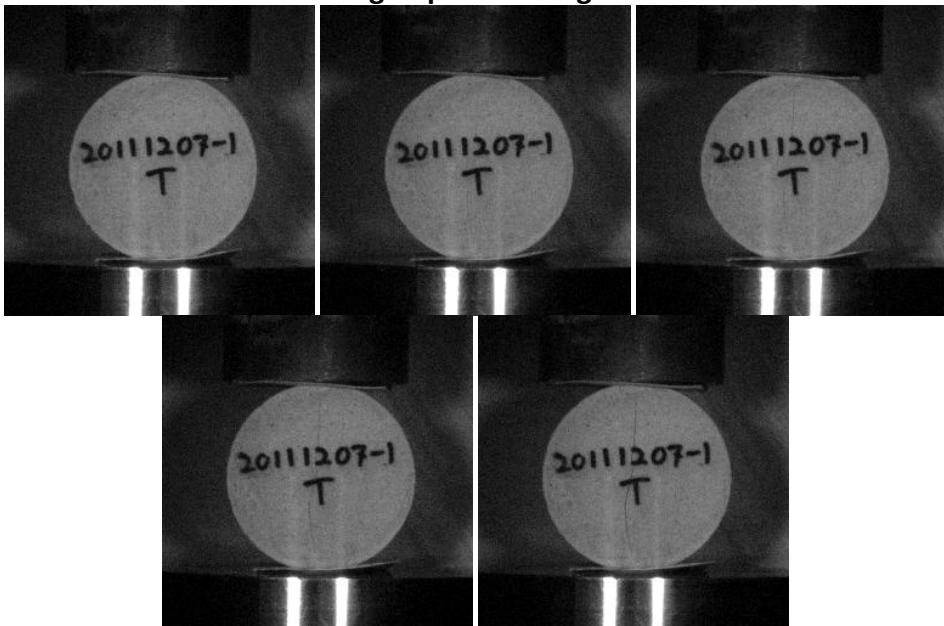
<p>The primary crack initiated at the centre of the specimen and propagated towards the top and bottom of the specimen.</p>
<p style="text-align: center;">Specimen after the test</p>

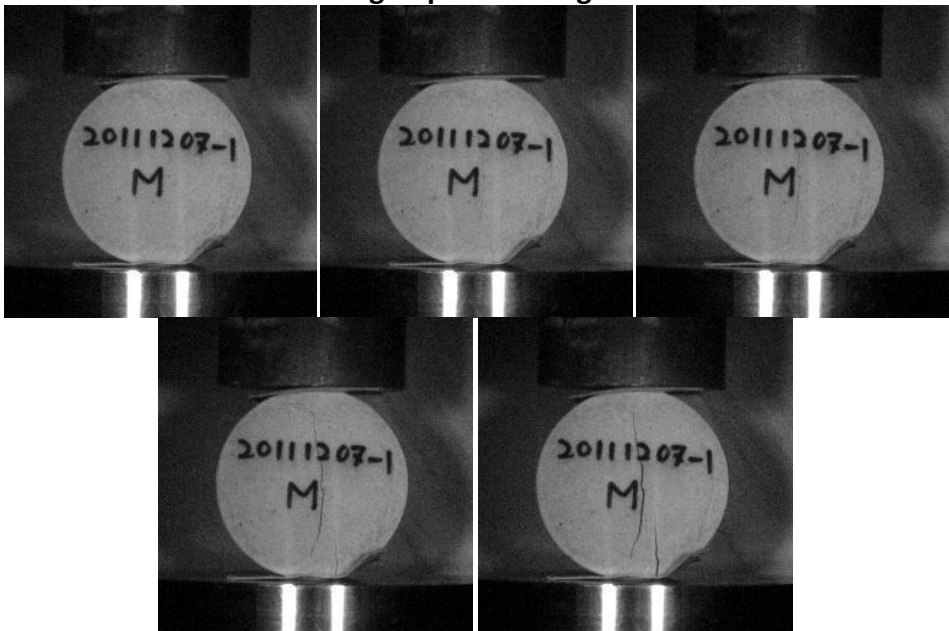
<p>The primary crack initiated at the centre and propagated towards the top and bottom of the specimen. A secondary crack was formed at the bottom of the specimen after the primary crack has occurred.</p>
<p style="text-align: center;">Specimen after the test</p>
