Water saturation effects on the tensile strength of rocks

WATER SATURATION EFFECTS ON THE TENSILE STRENGTH OF ROCKS

A Final Year Project presented to the

Degree of Bachelor of Engineering

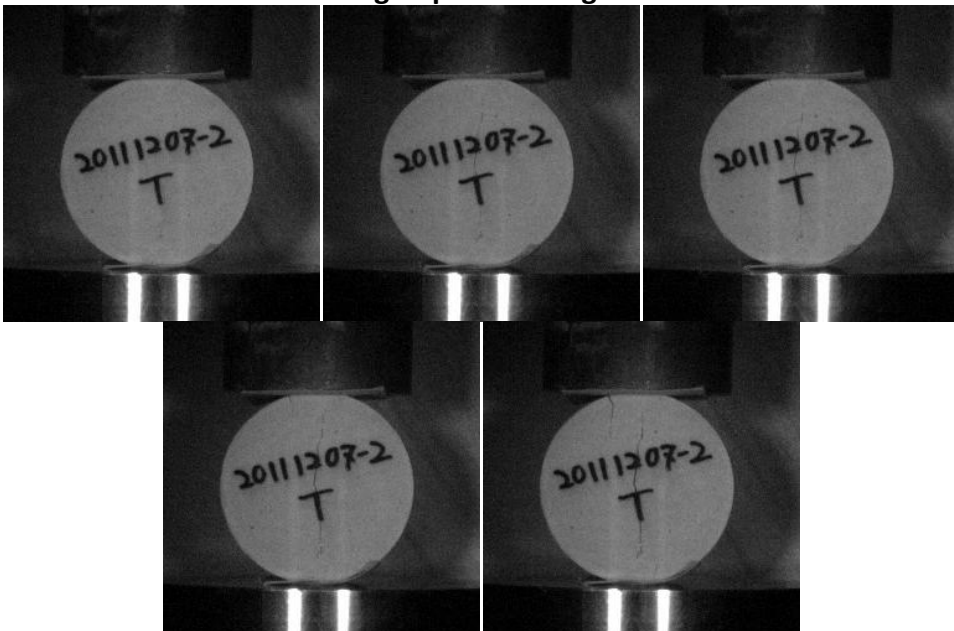
<p>The primary crack initiated at the centre and propagated towards the top and bottom of the specimen. A secondary crack was formed at the top of the specimen after the primary crack has occurred.</p>
<p align="center">Specimen after the test</p>

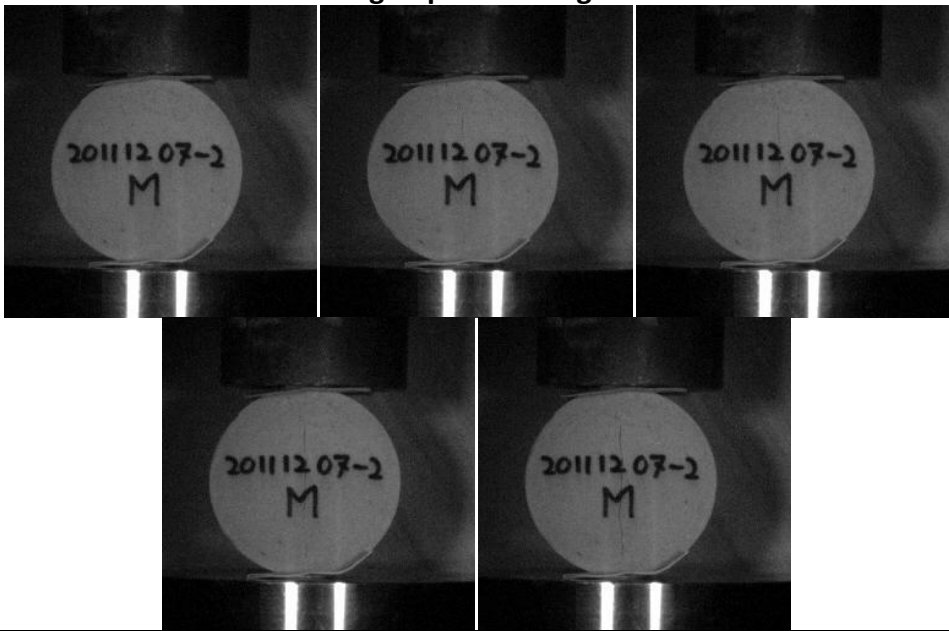
<p>The primary crack initiated at the centre and propagated towards the top and bottom of the specimen.</p>
<p style="text-align: center;">Specimen after the test</p>

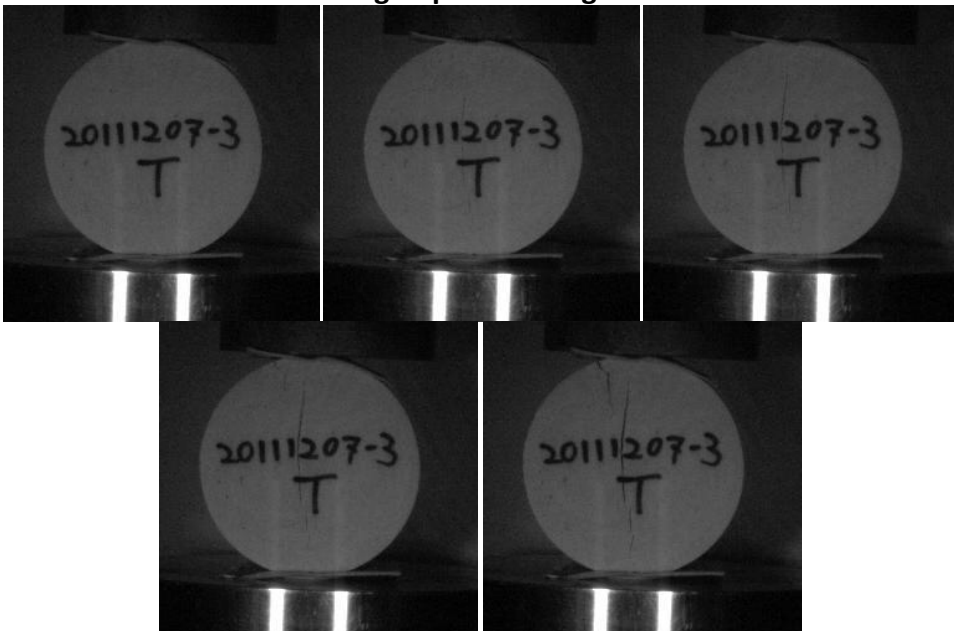
<p>The primary crack initiated at the centre and propagated towards the top and bottom of the specimen. A secondary crack was formed at the top of the specimen after the primary crack has occurred.</p>
<p style="text-align: center;">Specimen after the test</p>

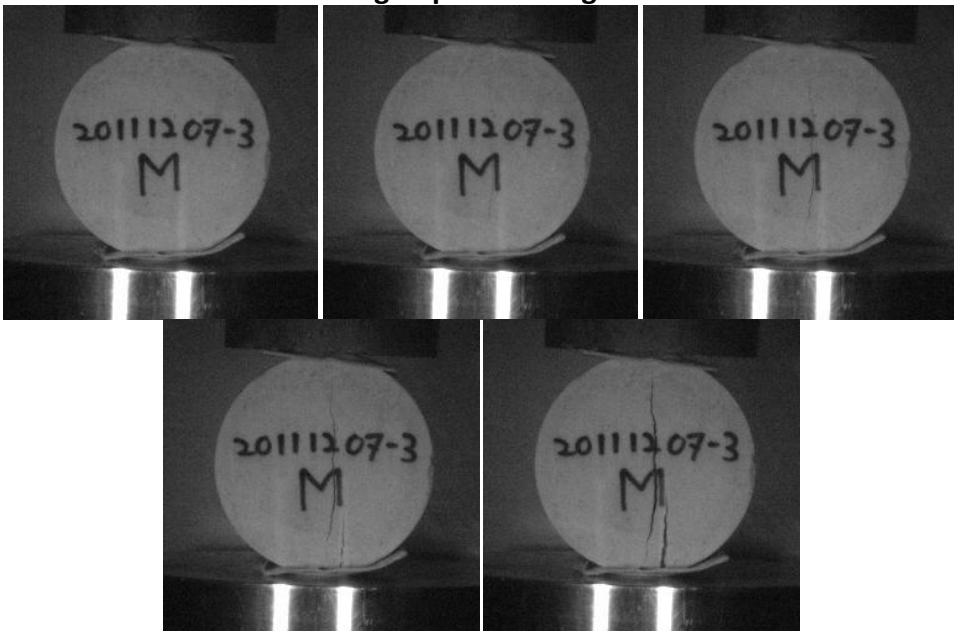
<p>The primary crack initiated at the centre and propagated towards the top and bottom of the specimen. A secondary crack was formed at the bottom of the specimen after the primary crack has occurred.</p>
<p style="text-align: center;">Specimen after the test</p>

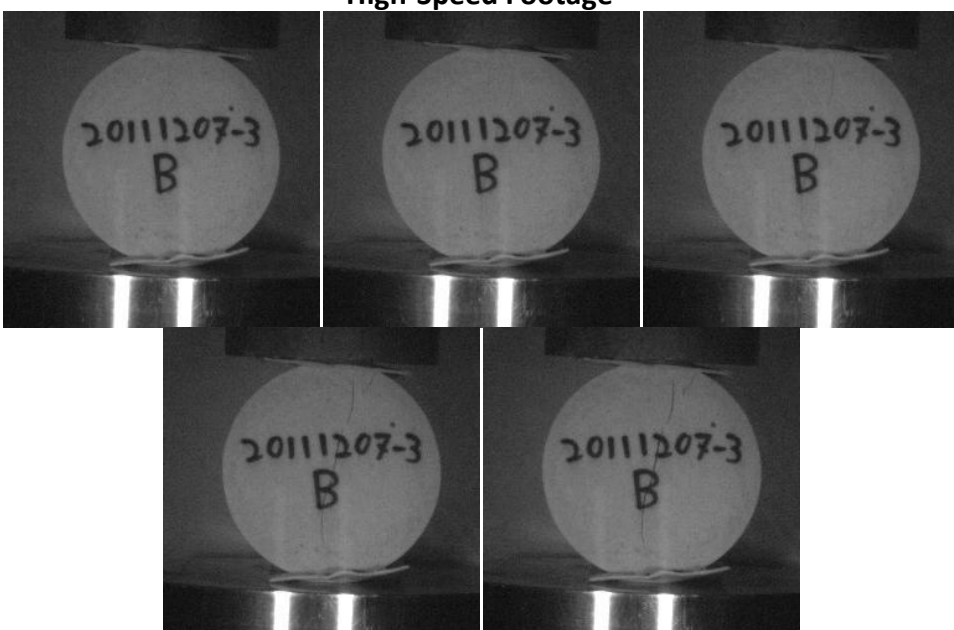
<p>The primary crack initiated at the centre and propagated towards the top and bottom of the specimen. A secondary crack was formed at the top of the specimen after the primary crack has occurred.</p>
<p>Specimen after the test</p>

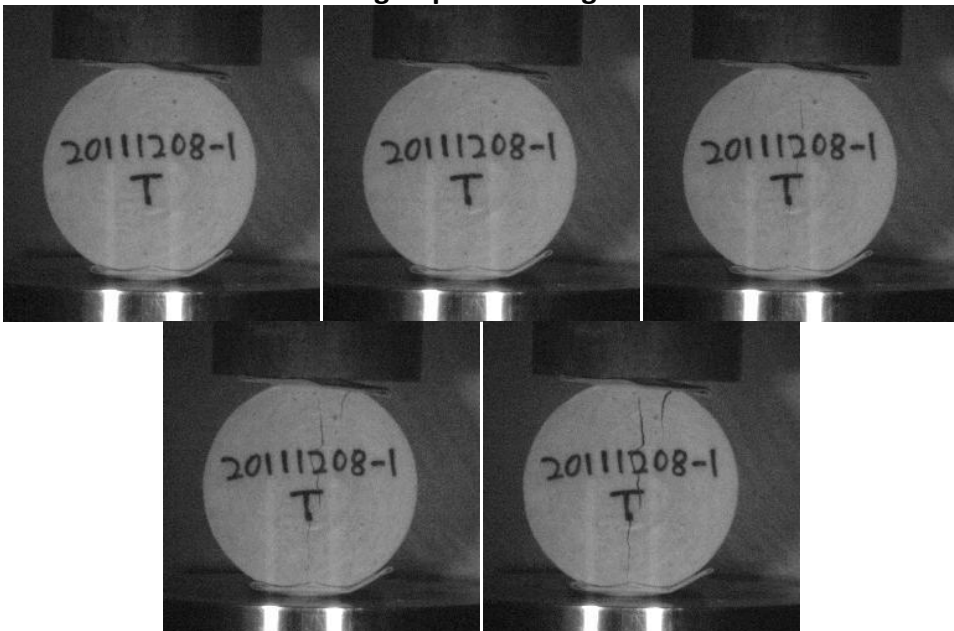
<p>The primary crack initiated at the top and propagated into the centre until it reached the bottom of the specimen. A secondary crack was formed at the top of the specimen after the primary crack has occurred.</p>
<p style="text-align: center;">Specimen after the test</p>

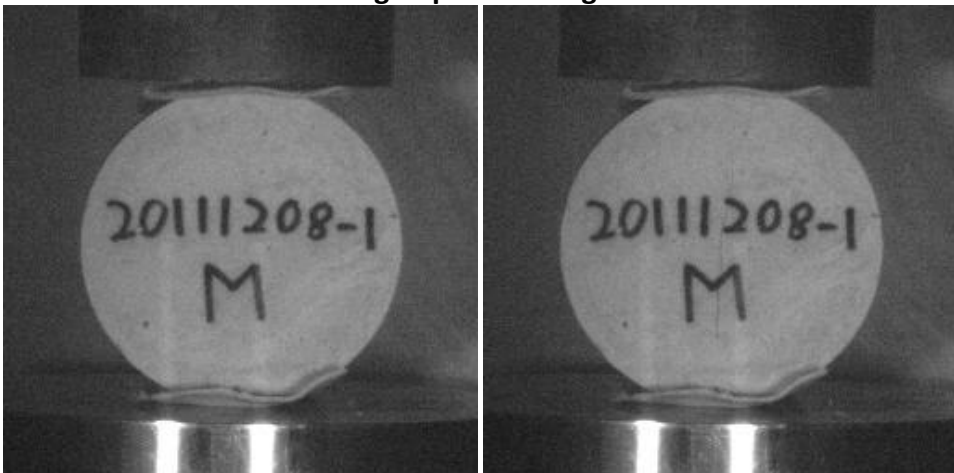
<p><u>Immersion Time</u> 3 weeks</p> <p><u>Diameter</u> 50mm</p> <p><u>Thickness</u> 30.1mm</p> <p><u>Max Load</u> 4.23591kN</p> <p><u>Tensile Strength</u> 1.792MPa</p> <p><u>Stiffness</u> 13.83kN/mm</p>
<p style="text-align: center;">High-Speed Footage</p>

<p>The crack initiated at the centre of the specimen.</p>
<p style="text-align: center;">Specimen after the test</p>

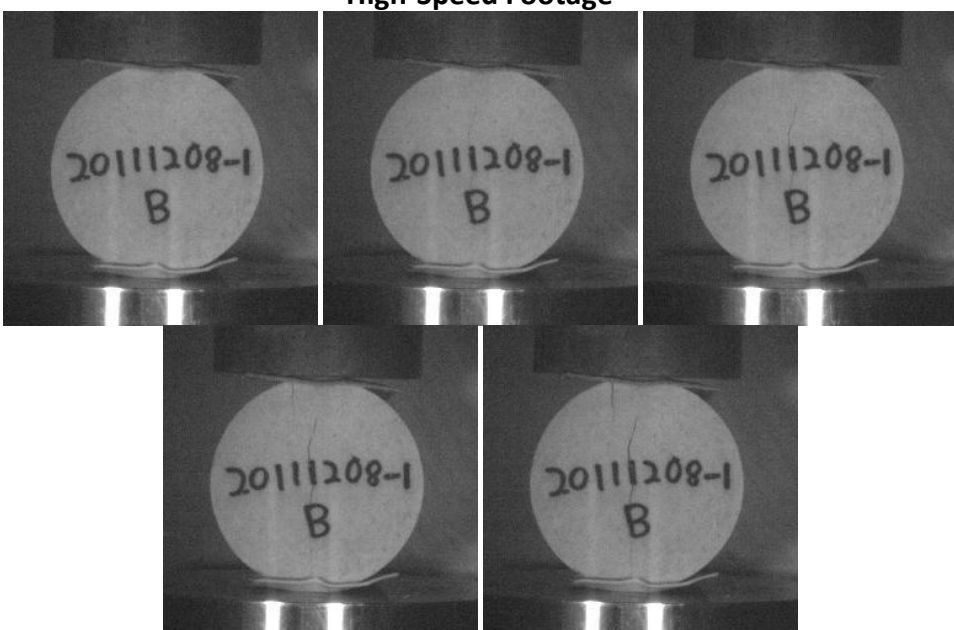
<p>The primary crack initiated at the centre and propagated towards the top and bottom of the specimen. A secondary crack was formed at the top of the specimen after the primary crack has occurred.</p>
<p>Specimen after the test</p>

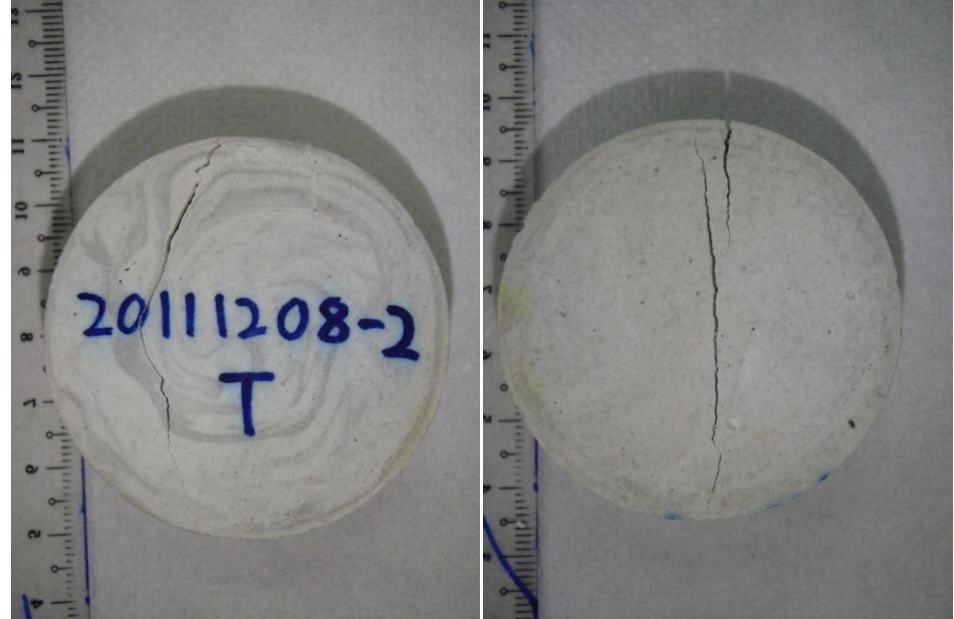
<p>The test result of this specimen was discarded due to the initiation of the primary crack along pre-existing flaw in the specimen.</p>

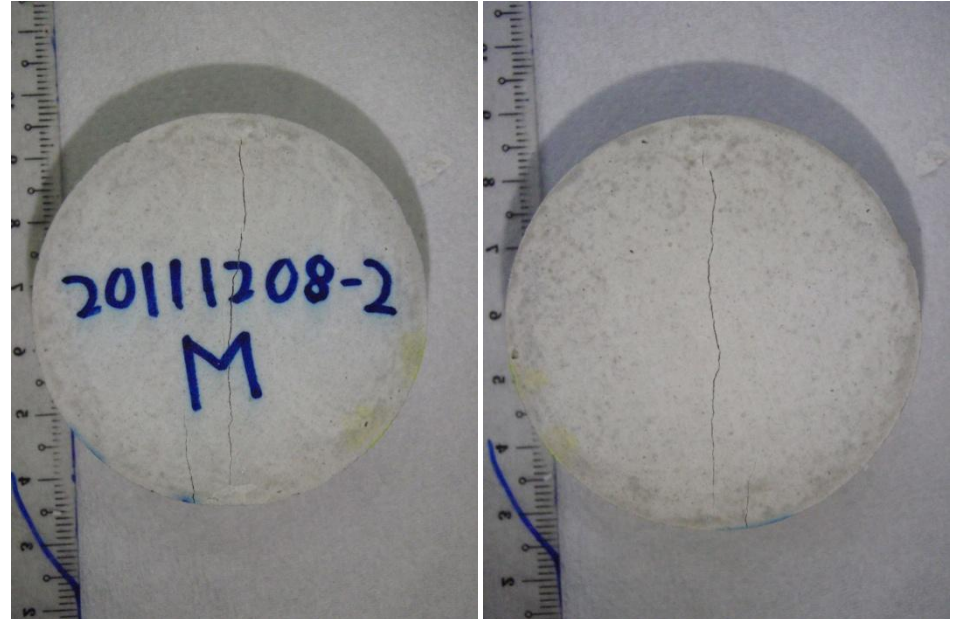
<p>A secondary crack was formed at the bottom of the specimen after the primary crack has occurred.</p>

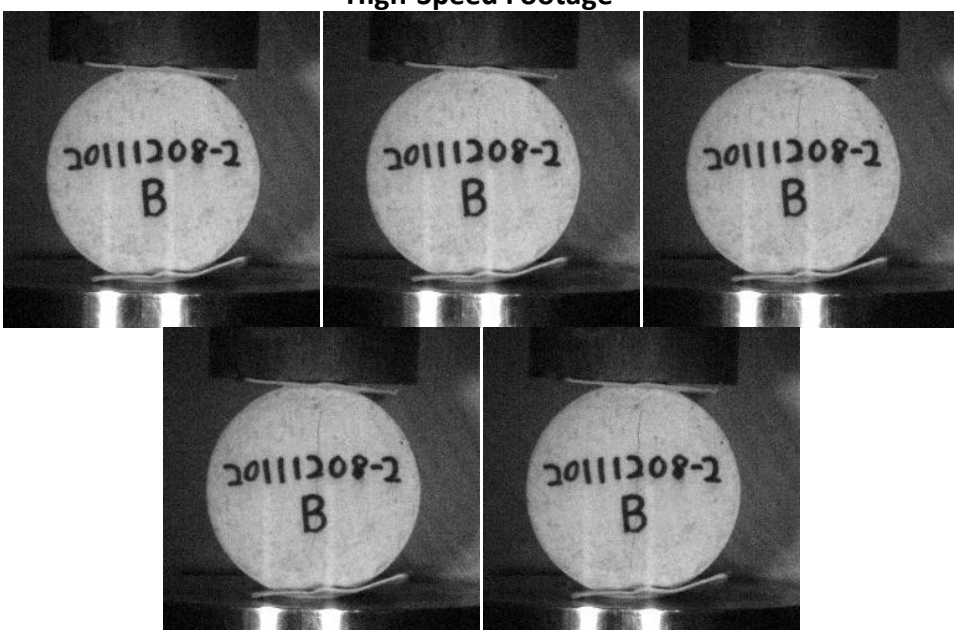
<p>The primary crack initiated at the top and propagated into the centre until it reached the bottom of the specimen.</p>
<p>Specimen after the test</p>

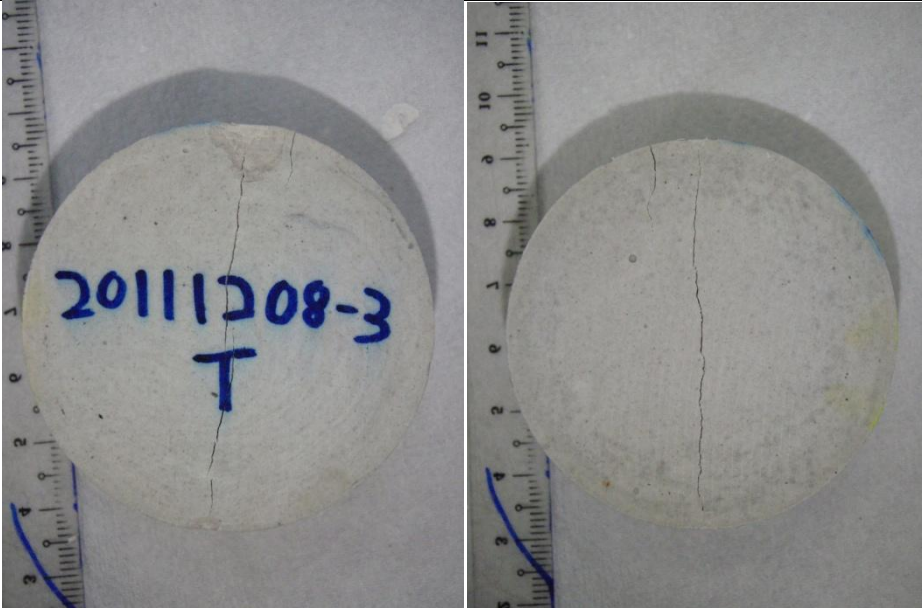
<p>As the primary crack occurred along the vertically-loaded diameter of the specimen, the test result was still considered valid although it is not known where the crack initiated in the specimen.</p>

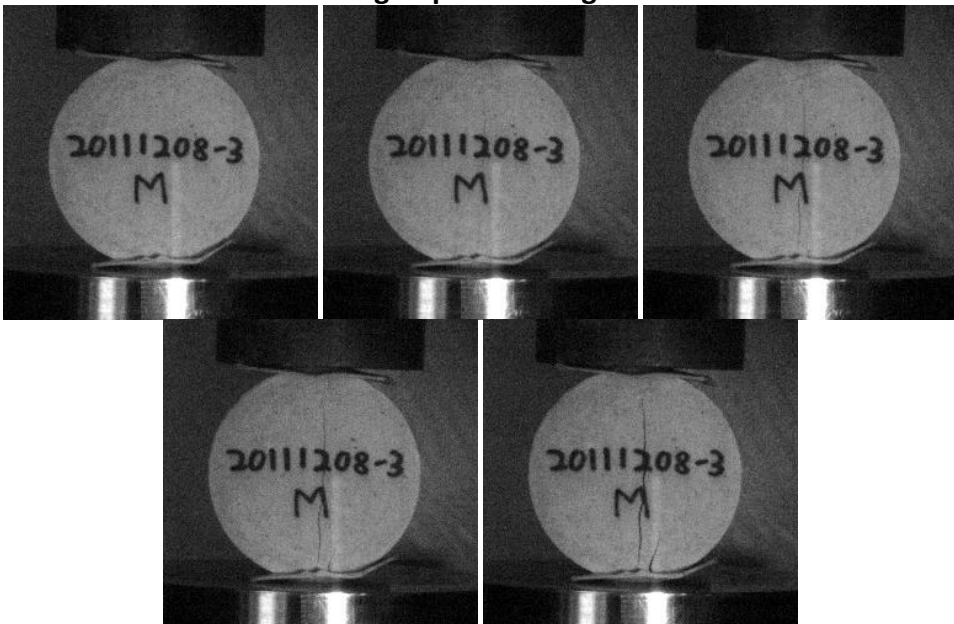
<p>The primary crack initiated at the centre and propagated towards the top and bottom of the specimen. A secondary crack was formed at the bottom of the specimen after the primary crack has occurred.</p>
<p style="text-align: center;">Specimen after the test</p>

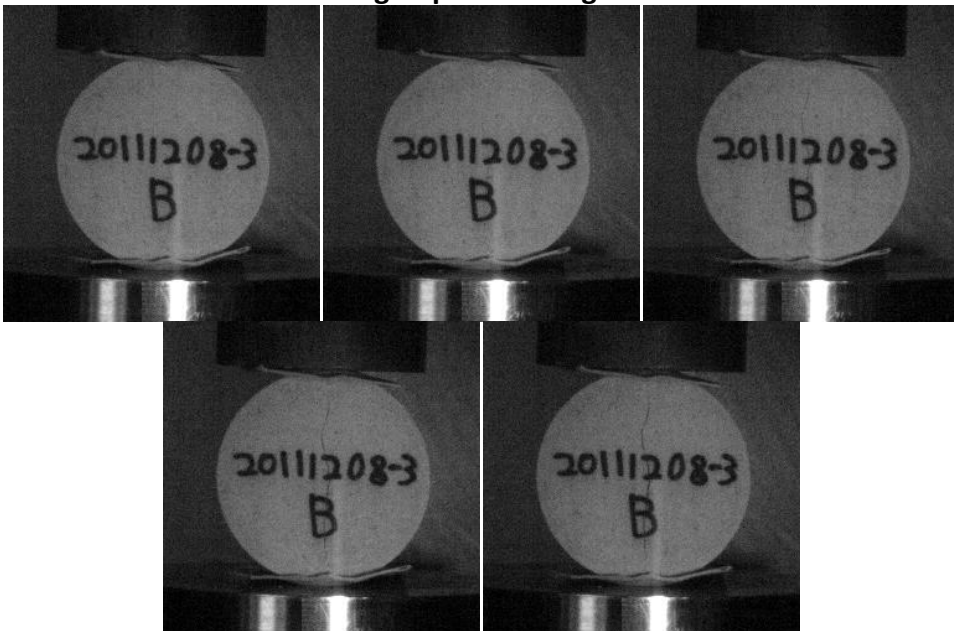
<p>The primary crack initiated at the centre and propagated towards the top and bottom of the specimen.</p>
<p style="text-align: center;">Specimen after the test</p>

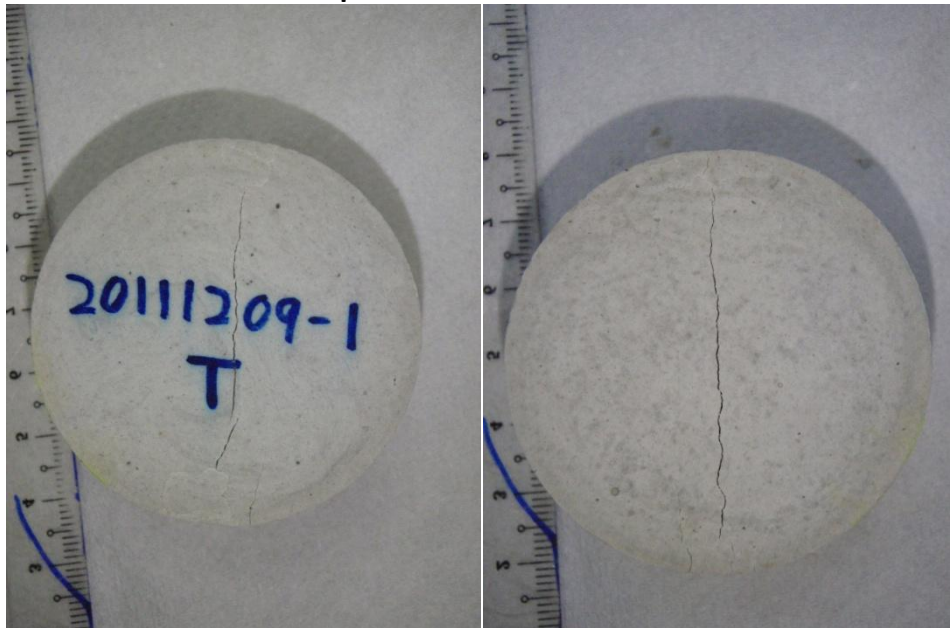
<p>Physical inspection of the specimen showed that the primary crack did not break through the top and bottom of the specimen. Hence, it can be deduced that the crack initiated at the centre of the specimen and tensile failure has occurred.</p>

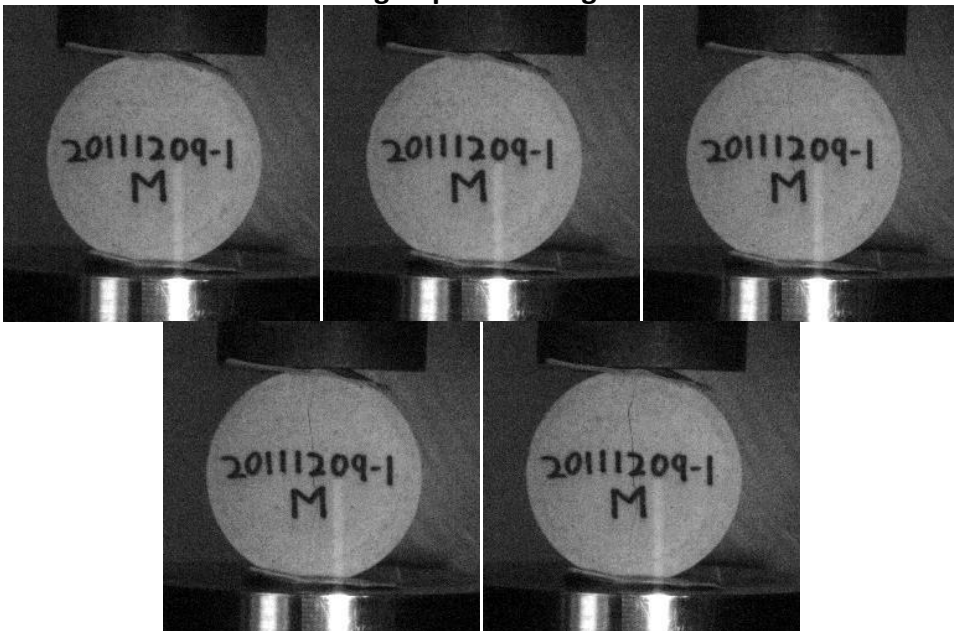
<p>The primary crack initiated at the centre and propagated towards the top and bottom of the specimen.</p>
<p>Specimen after the test</p>

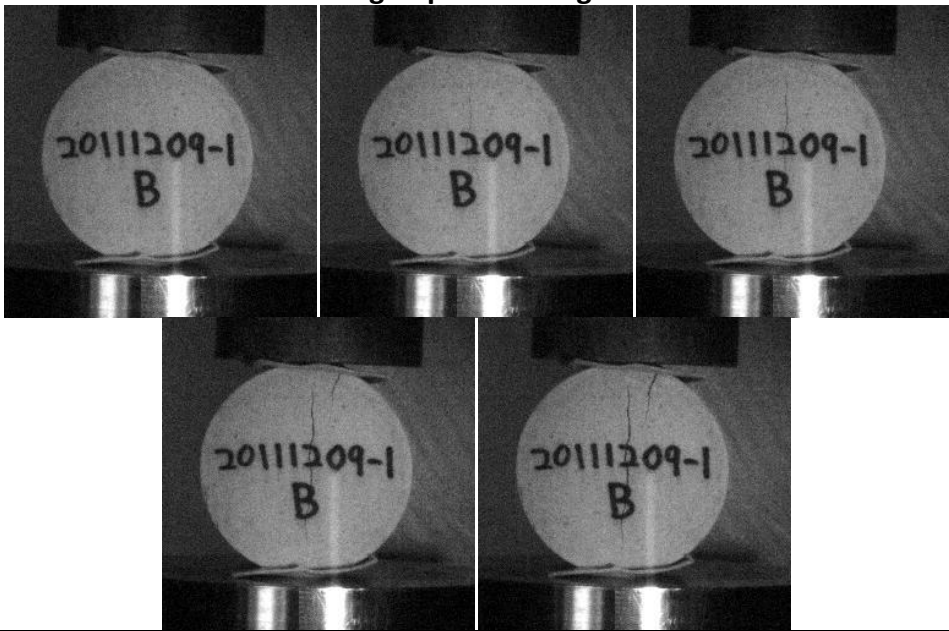
<p>The primary crack initiated at the centre and propagated towards the top and bottom of the specimen. A secondary crack was formed at the top of the specimen after the primary crack has occurred.</p>
<p>Specimen after the test</p>

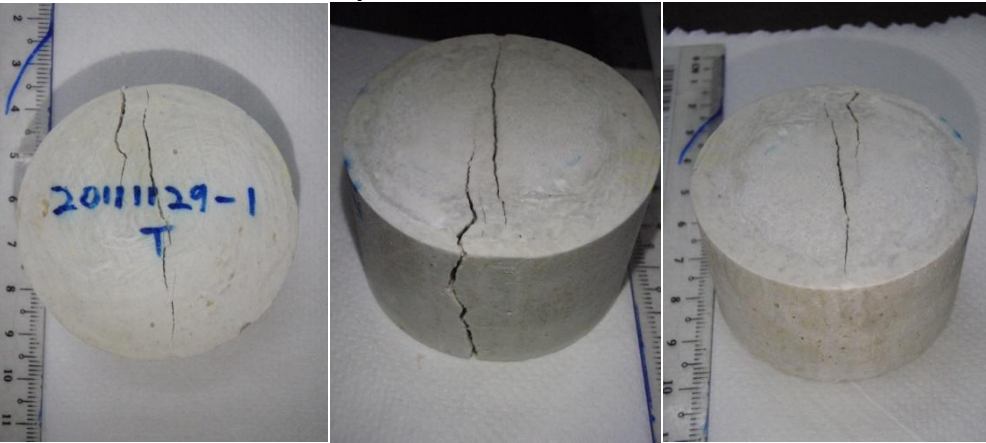
Specimen No: 20111129-1M

<p><u>Immersion Time</u> 10 weeks</p> <p><u>Diameter</u> 50mm</p> <p><u>Thickness</u> 31.5mm</p> <p><u>Max Load</u> 5.19503kN</p> <p><u>Tensile Strength</u> 2.100MPa</p> <p><u>Stiffness</u> 18.571kN/mm</p>
<p style="text-align: center;">High-Speed Footage</p> <p style="text-align: center;"><i>Not Available</i></p>	
<p style="text-align: center;">Specimen after the test</p>

<p>Physical inspection of the specimen showed that the primary crack did not break through the top and bottom of the specimen. Hence, it can be deduced that the crack initiated at the centre of the specimen and tensile failure has occurred.</p>

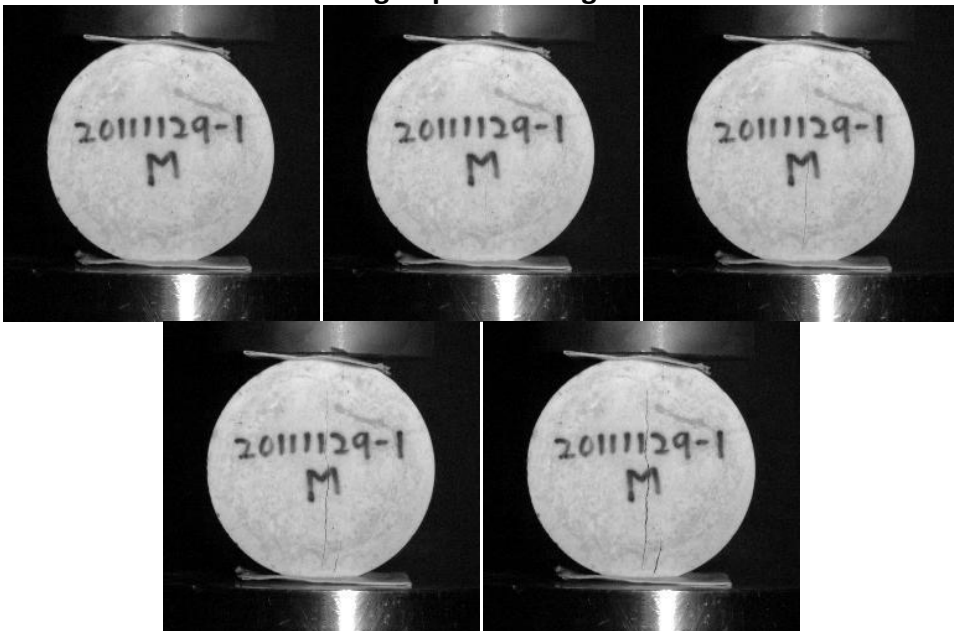
<p>The primary crack initiated at the centre and propagated towards the top and bottom of the specimen. A secondary crack was formed at the bottom of the specimen after the primary crack has occurred.</p>
<p>Specimen after the test</p>

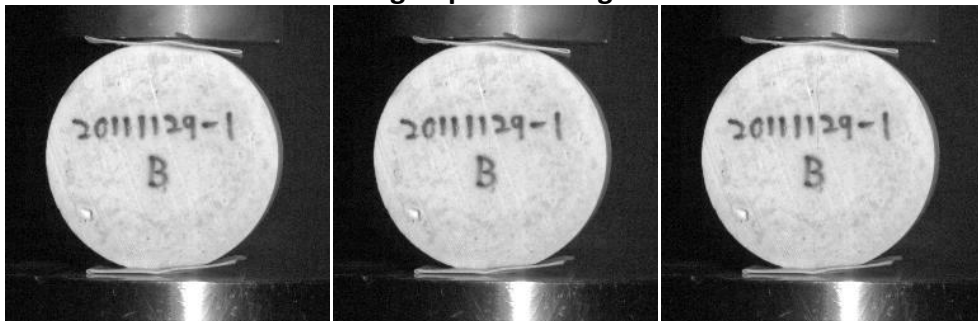
<p>Applied Load (kN)</p> <p>$y = 21.029x + 1.9216$</p> <p>δ (mm)</p>	<p><u>Immersion Time</u> 10 weeks</p> <p><u>Diameter</u> 50mm</p> <p><u>Thickness</u> 31.4mm</p> <p><u>Max Load</u> 5.14311kN</p> <p><u>Tensile Strength</u> 2.085MPa</p> <p><u>Stiffness</u> 21.029kN/mm</p>
<p>High-Speed Footage</p>

<p>It is unclear from the high-speed footage where the crack initiated in the specimen.</p>
<p>Specimen after the test</p>

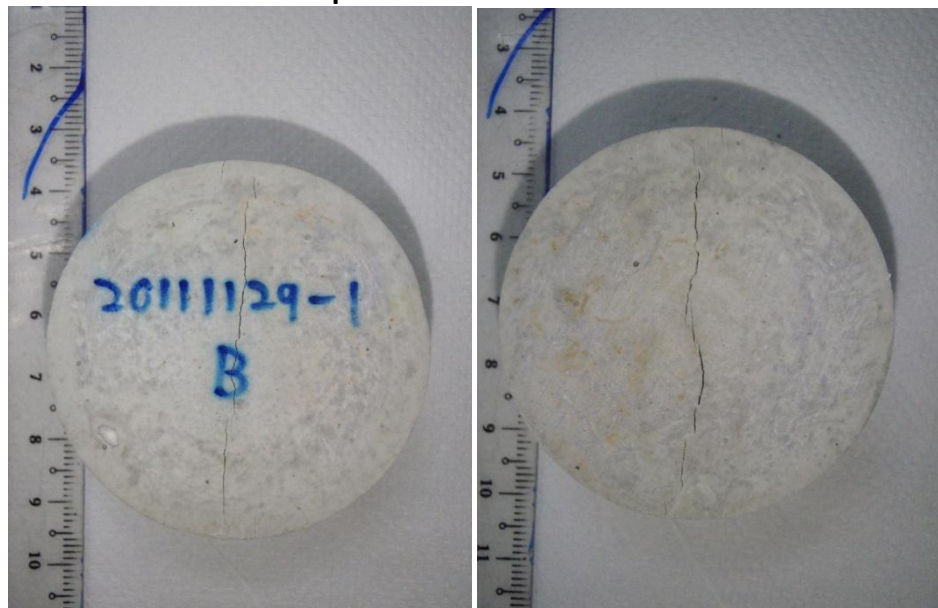
<p>Physical inspection of the specimen showed that the primary crack did not break through the top and bottom of the specimen. Hence, it can be deduced that the crack initiated at the centre of the specimen and tensile failure has occurred.</p>

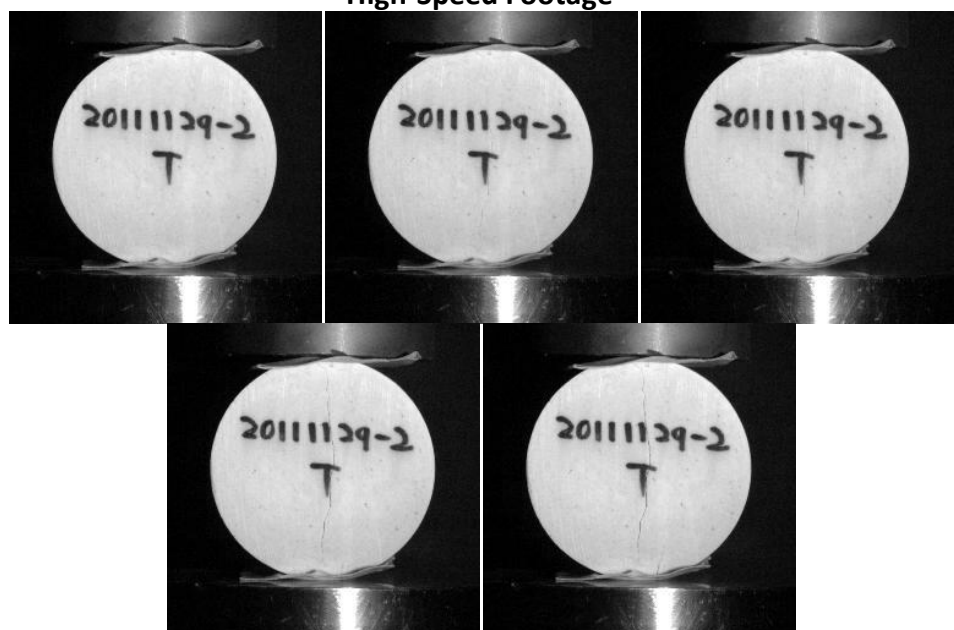
<p>The primary crack initiated at the centre and propagated towards the top and bottom of the specimen. A secondary crack was formed at the bottom of the specimen after the primary crack has occurred.</p>
<p>Specimen after the test</p>

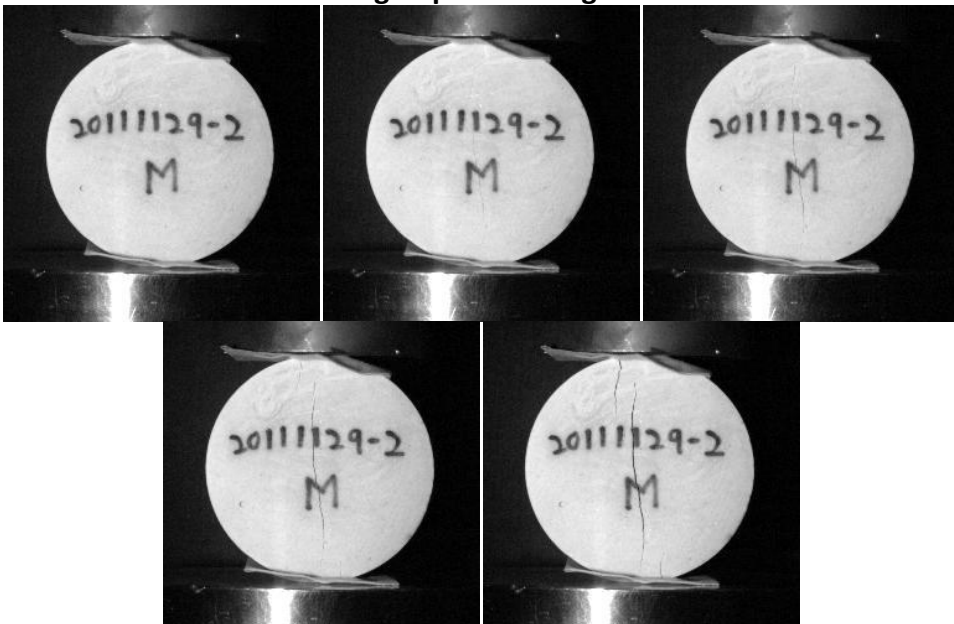
<p>The primary crack initiated at the centre and propagated towards the top and bottom of the specimen. A secondary crack was formed at the top and bottom of the specimen after the primary crack has occurred.</p>
<p style="text-align: center;">Specimen after the test</p>

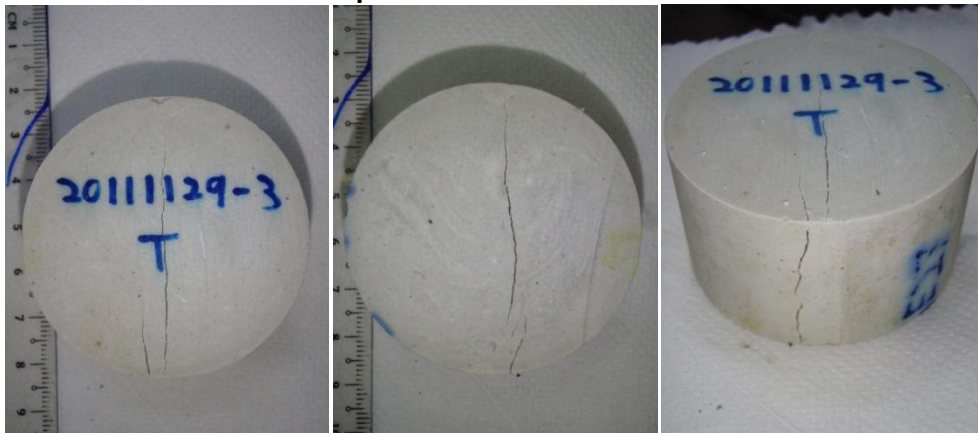
Specimen No: 20111129-3M

<p>The primary crack initiated at the centre and propagated towards the top and bottom of the specimen. A secondary crack was formed at the bottom of the specimen after the primary crack has occurred.</p>
<p>Specimen after the test</p>

<p>Physical inspection of the specimen showed that the primary crack did not break through the top and bottom of the specimen.</p>

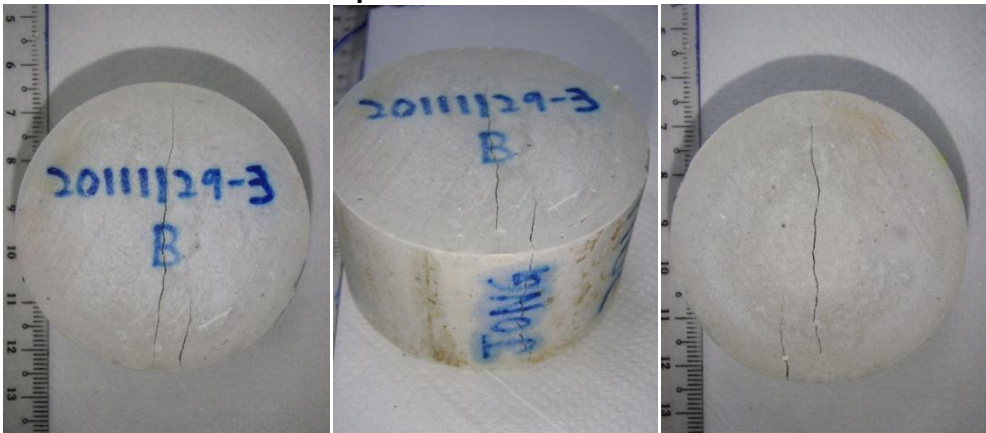
Specimen No: 20111130-1T

<p>The primary crack initiated at the centre and propagated towards the top and bottom of the specimen. A secondary crack was formed at the bottom of the specimen after the primary crack has occurred.</p>
<p>Specimen after the test</p>

<p>Physical inspection of the specimen showed that the primary crack did not break through the top and bottom of the specimen.</p>

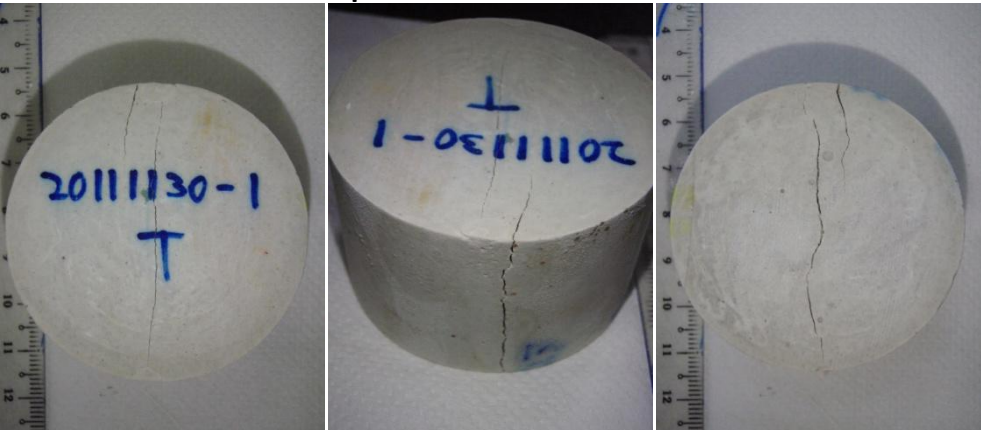
Specimen No: 20111130-1M

<p>The primary crack initiated at the centre and propagated towards the top and bottom of the specimen. A secondary crack was formed at the top of the specimen after the primary crack has occurred.</p>
<p style="text-align: center;">Specimen after the test</p>

<p>Physical inspection of the specimen showed that the primary crack did not break through the top and bottom of the specimen.</p>

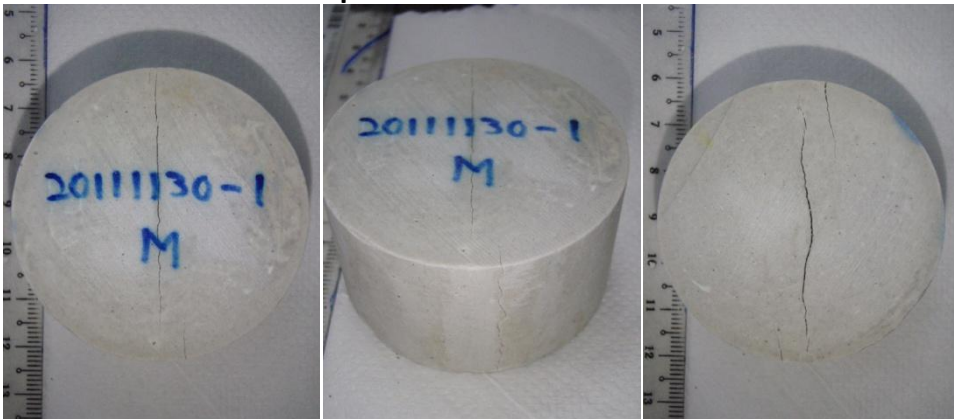
Specimen No: 20111130-1B

<p>The primary crack initiated at the centre and propagated towards the top and bottom of the specimen. A secondary crack was formed at the bottom of the specimen after the primary crack has occurred.</p>
<p>Specimen after the test</p>

<p>Physical inspection of the specimen showed that the primary crack did not break through the top and bottom of the specimen.</p>

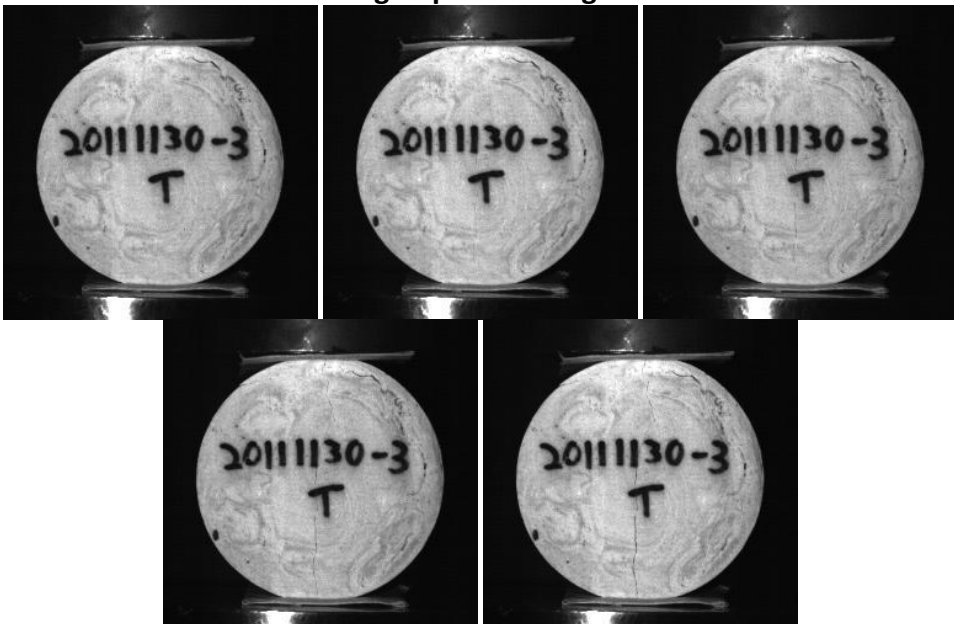
<p>Applied Load (kN)</p> <p>δ (mm)</p> <p>$y = 13.471x + 2.3671$</p>	<p><u>Immersion Time</u> 10 weeks</p> <p><u>Diameter</u> 50mm</p> <p><u>Thickness</u> 32.8mm</p> <p><u>Max Load</u> 4.42414kN</p> <p><u>Tensile Strength</u> 1.717MPa</p> <p><u>Stiffness</u> 13.471kN/mm</p>
<p style="text-align: center;">High-Speed Footage</p>

<p>The primary crack initiated at the centre and propagated towards the top and bottom of the specimen.</p>
<p style="text-align: center;">Specimen after the test</p>

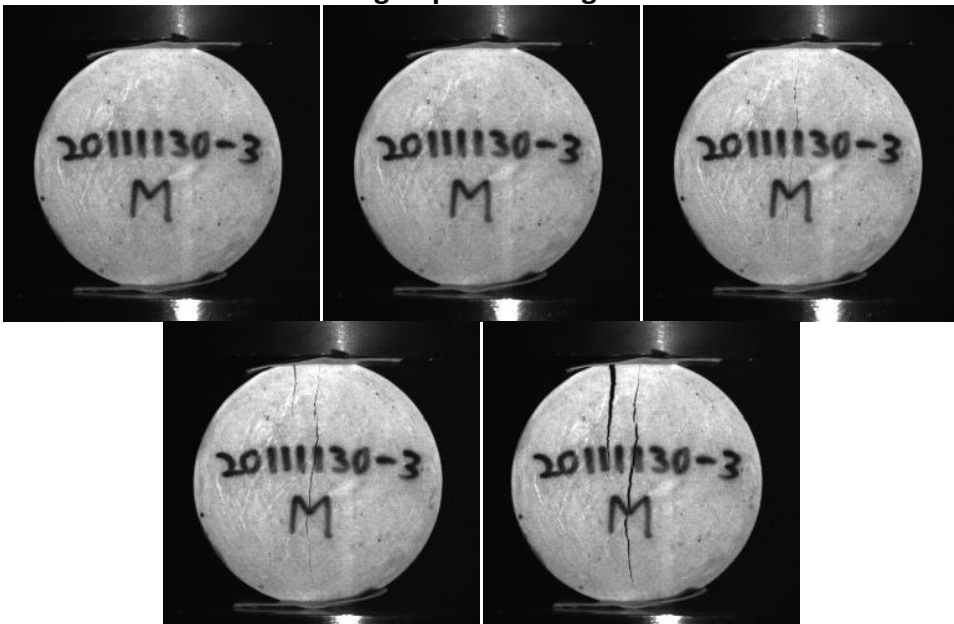
<p style="text-align: right;">$y = 18.311x + 2.3836$</p>	<p><u>Immersion Time</u> 10 weeks</p> <p><u>Diameter</u> 50mm</p> <p><u>Thickness</u> 30.1mm</p> <p><u>Max Load</u> 6.09773kN</p> <p><u>Tensile Strength</u> 2.579MPa</p> <p><u>Stiffness</u> 18.311kN/mm</p>
<p style="text-align: center;">High-Speed Footage</p>

<p>The first crack appeared at the centre while a second crack was initiated at the top of the specimen. The two cracks propagated and became connected to form the main diametrical crack. Another secondary crack was formed at the top of the specimen after the primary crack has occurred.</p>
<p style="text-align: center;">Specimen after the test</p>
