# **GEOBARRIER SYSTEM FOR USE IN UNDERGROUND STRUCTURE**

*Research Collaboration between:*

**Nanyang Technological University  
Housing & Development Board**

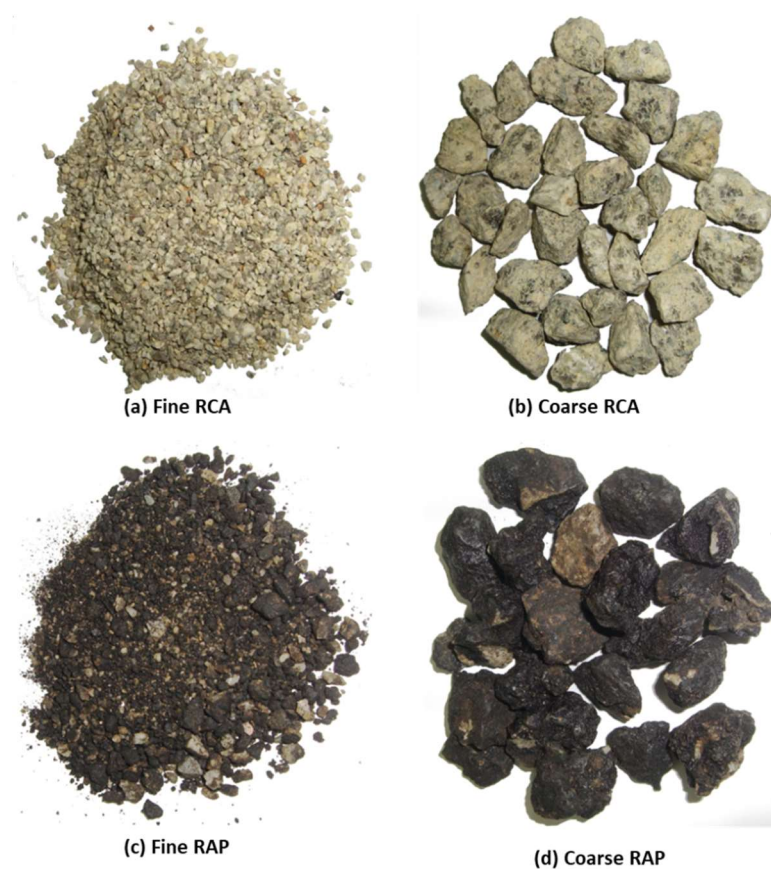
**Figure 2. RCA and RAP used for construction of GBS at Pilot study site**

Recycled concrete aggregates (RCA) and reclaimed asphalt pavement (RAP) were used for the construction of GBS. The fine-grained material (fine RCA or fine RAP) was wrapped in a geobag and stacked on top of each other on the wall face to form a retaining wall. Coarse RCA or coarse RAP was placed behind the geobags to limit water infiltration into the compacted residual soil. The materials used for the construction of the GBS were selected in such a way that the system will not cause any adverse effect to the environment. Toxicity characteristic leaching procedure (TCLP) were conducted on the RCA and RAP to ensure that the discharge from GBS will not cause contamination. The test results showed that both RCA and RAP used in the Pilot study did not contain any hazardous chemical. The RCA and RAP used for the construction of GBS at the pilot study site are shown in [Figure 2](#).

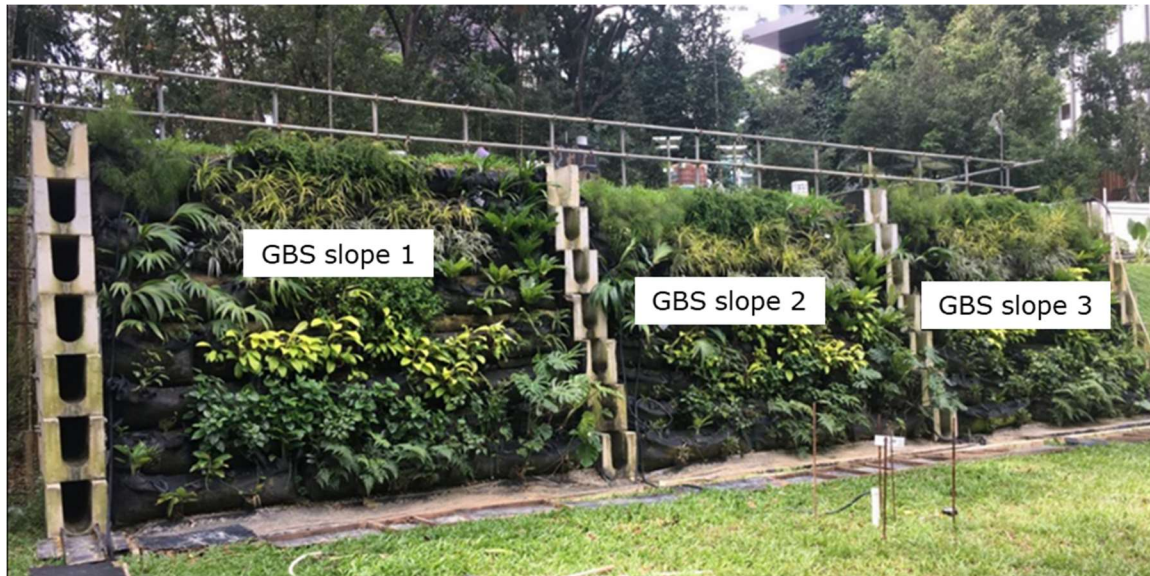
**Figure 5: Appearance of GBS with green cover**

The plants to be used as green cover in GBS are classified as deep rooted grass and small shrub. Deep-rooted grass need minimal irrigation, fertilizer or maintenance. Some of them grow quickly from seed while others are laid more successfully as sod. When deep-rooted grass grows well, they can reach 150–400 mm high and 150–400 mm diameter. The number of plants per 1 square meter is 14–5. There are many varieties of deep-rooted grass and small shrub, however the species of plants are suggested for the green cover of the GBS are shown in Table 2. The appearance of a completed GBS system with green cover is shown in Figure 5.

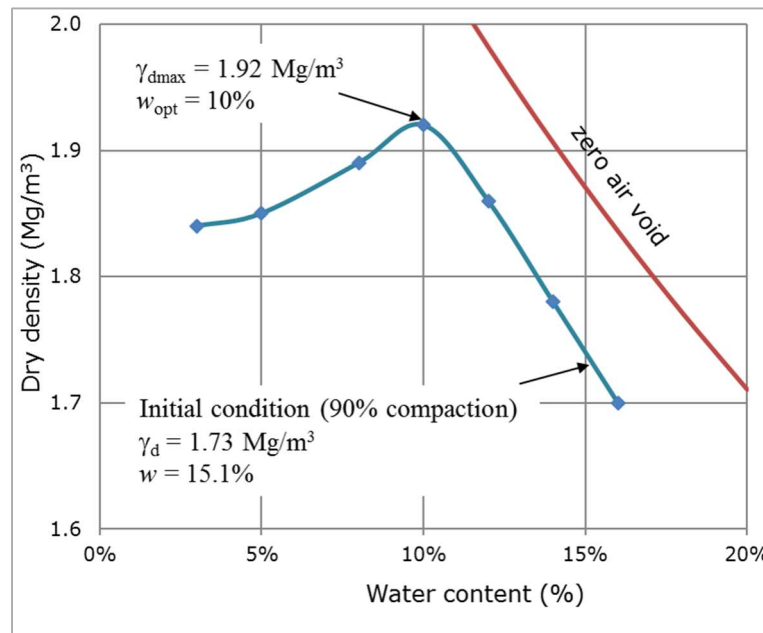
Figure 10: Laboratory compaction curve for reinforced soil fill

The reinforced soil was derived from in-situ residual soil. The soil was compacted to 90% of compaction level based on the maximum density obtained from laboratory compaction curve. The compaction test was carried out following ASTM D698-12. Figure 10 shows the compaction curve of residual soil from Layer 1. Based on the compaction curve, the maximum dry density and optimum water content for the compaction of the residual soil are  $1.92 \text{ Mg/m}^3$  and 10%, respectively. For the pilot study, the soil was compacted at dry density of higher than  $1.73 \text{ Mg/m}^3$  and water content of 15.1%.

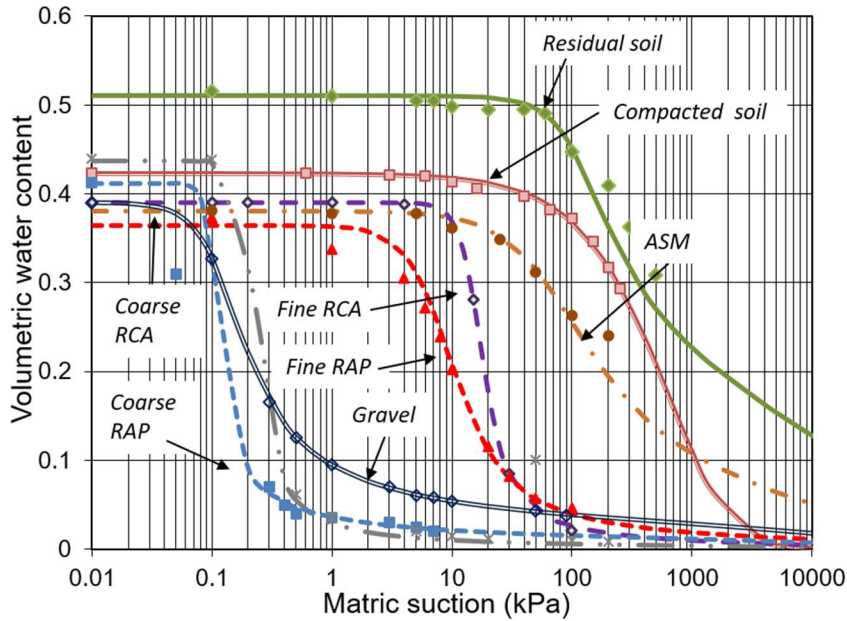
Figure 18: Drying SWCC of in-situ soil and construction materials of GBS slopes

Most apparatuses can be used to perform SWCC test for drying process. However, it is important to plot the SWCC for drying and wetting process because most of the geotechnical problems, such as slope failure, are induced by rainfall that generally causes a wetting process in soil. Thus, the SWCC tests were carried out in this study under both drying and wetting processes using various apparatuses available at NTU Geotechnics Laboratory. The SWC drying curves of residual soil from the pilot study site as well as construction materials for GBS slopes are presented in Figure 18 while the wetting curves

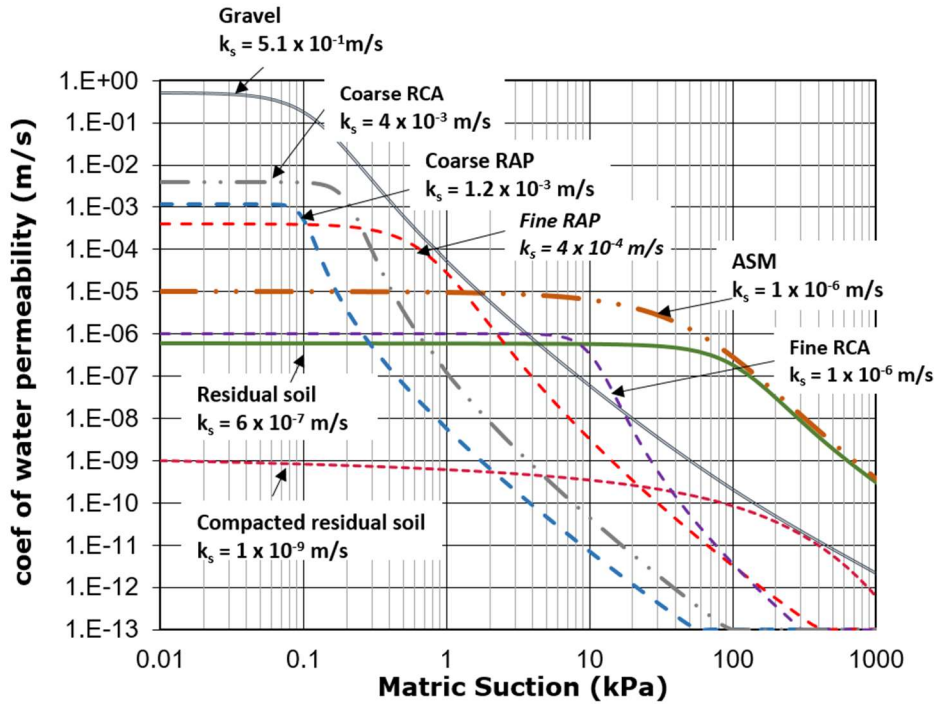
Figure 20: Permeability functions of residual soil and GBS construction materials

The determination of unsaturated coefficient of permeability by experiment is a tedious and time-consuming process. Therefore, an indirect method using a statistical model is commonly used to predict the permeability function from the saturated coefficient of permeability,  $k_s$ , and the soil-water characteristic curve (Fredlund and Xing, 1994; Marshall, 1958; Millington and Quirk, 1959, 1961; Kunze, 1968; Green and Corey, 1971). The calculated permeability data can then be fitted using the mathematical equation as suggested by Leong and Rahardjo (1997). In this study, the drying and wetting permeability functions were both considered. However, previous study (Tami et al, 2004) showed that wetting permeability function is more suitable for the study of rainfall infiltration under both drying and wetting conditions. Figures 20 shows the wetting permeability functions of the residual soil and all construction materials used for the construction of GBS at the pilot study site.

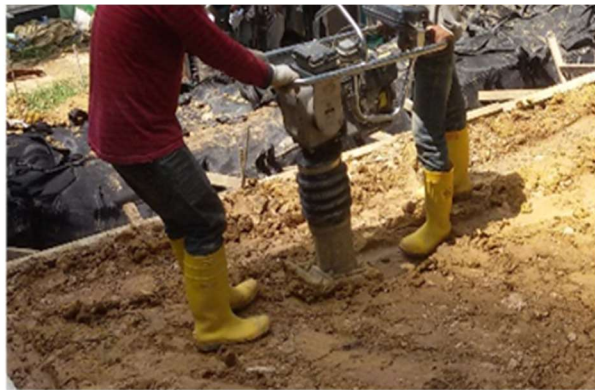
(b) Compaction of residual soil behind Capillary barrier

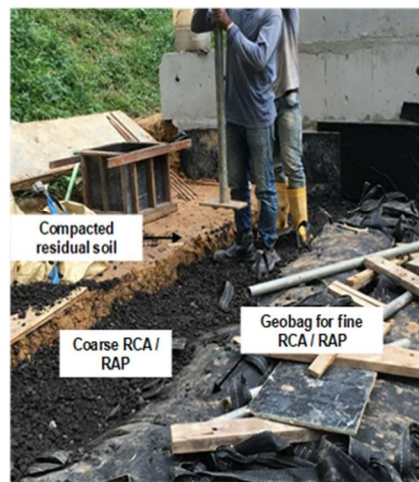
(c) Placement of coarse RCA/coarse RAP

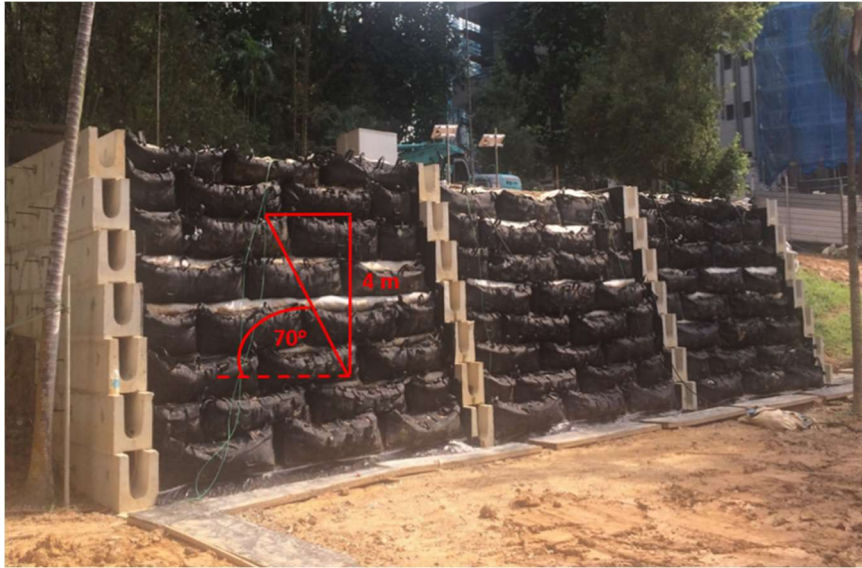
Figure 25: Completed GBS slopes at field pilot study site Orchard Boulevard

In the final stage of the GBS construction (at the crest of the slope), the coarse RCA/coarse RAP was placed directly above the ground surface behind the ASM geobag. Then, geofabric was placed on top of the coarse RCA/coarse RAP before placement of fine RCA/fine RAP. Another geofabric layer was placed before laying ASM layer. Then surface drain was constructed at the back and both sides of the GBS slopes. Vegetations were planted in each pocket of the ASM geobag upon the completion of the GBS slopes. The crest of the GBS slopes were then covered by turfing on the ASM layer. [Figure 25](#) and [26](#) show the completed GBS and the GBS with green cover, respectively.

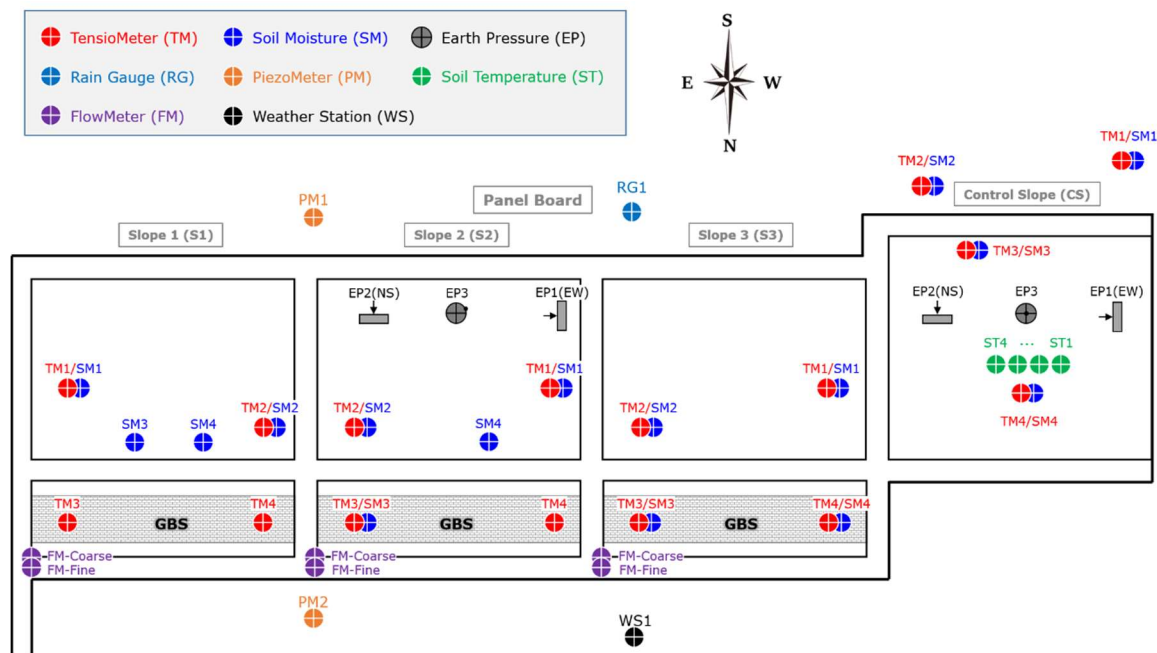
Figure 27: Plan view of slopes at pilot study site with instrumentation locations

Field instrumentation and monitoring was carried out on the GBS slopes and one section of the original slope to monitor the effect of rainfall on the pore water pressure and slopes deformation. The sensors used in the field instrumentation consisted of rain gauge, piezometers, tensiometers, soil moisture sensors, water flow meter, and earth pressure sensor to measure the slope deformation. All data were collected in a data-logger and transmitted via internet for remote access to enable real time observation. The monitoring period was one year commencing on 1<sup>st</sup> July 2016. The plan view of the slopes and instrumentation locations is presented in Figure 27. The diagram of the GBS slopes and the Original slope constructed for this field study together with the layout of monitoring instruments are shown in Figure 28.

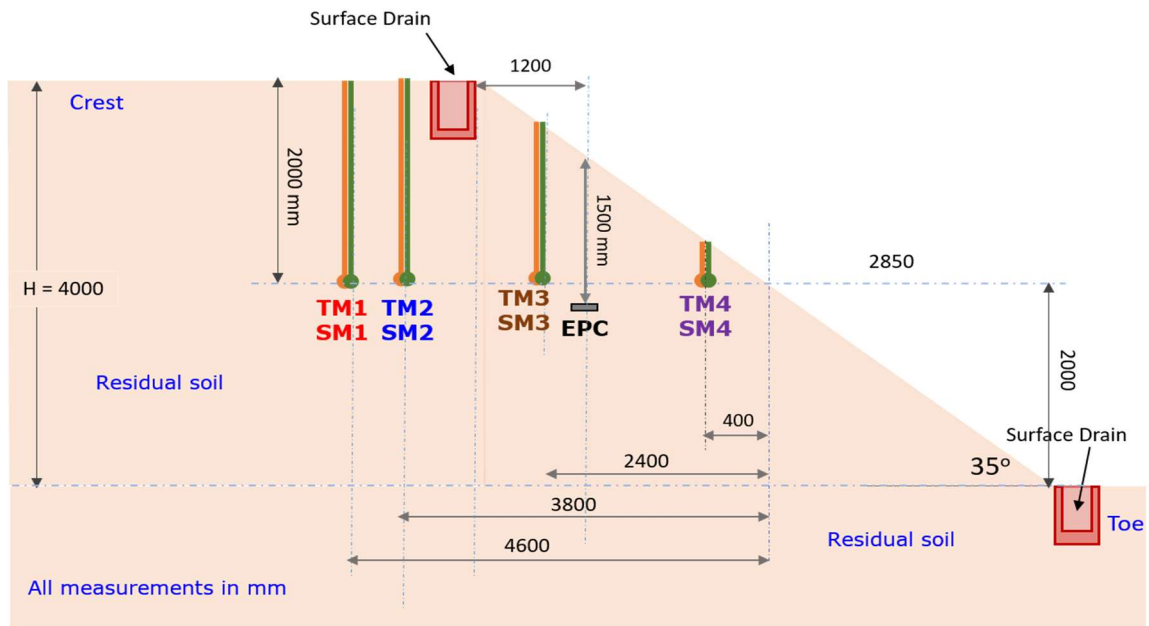
(b) Original slope

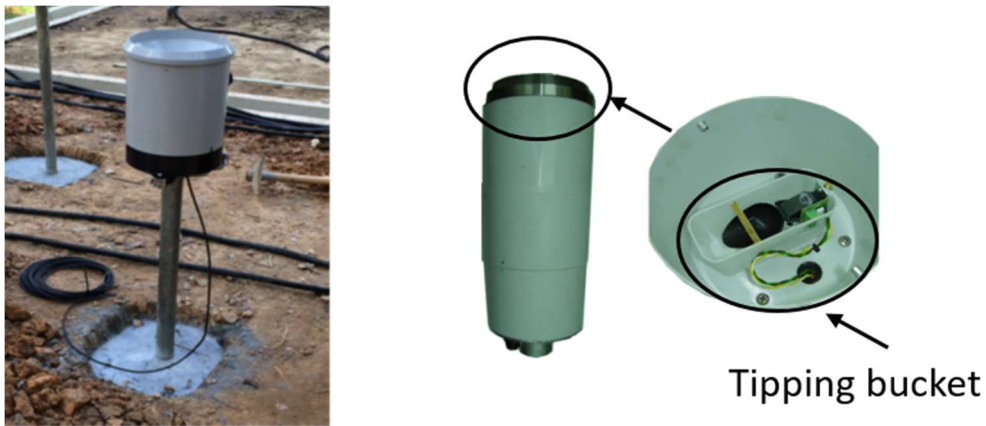
**Figure 29: Tipping bucket rainfall gauge installed at the study site**

The study area was instrumented with a rain-gauge (Figure 29) to monitor rainfall. The rain-gauge was located at 1.6 m above the ground on an open area of the slope crest to determine the rainfall intensity. A tipping bucket rainfall gauge, connected to a magnetic-reed switch, was chosen to collect the rainfall data. Regular maintenance of the rainfall gauge was conducted twice a week as dust and insects might enter the tipping bucket and affected the accuracy of measurement.

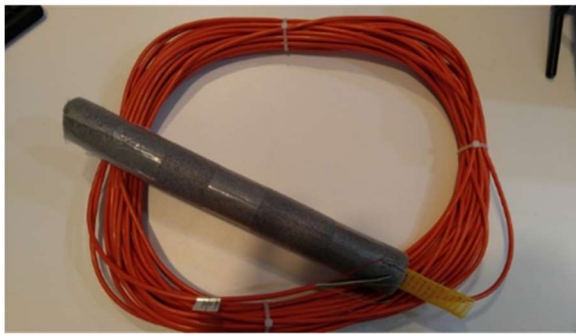
The response of groundwater to rainfall was monitored by two piezometers installed at depth of 7 m at the crest and depth of 4 m at toe of the slope. The piezometers, of Cassagrande type (Figure 30) is widely used for groundwater table monitoring in slope because they consist of economical components, simple to read, and have long-term reliability. The piezometer tip was embedded in sand layer that is isolated by two sand bentonite layers. A grout (i.e., mixture of sand and bentonite) was placed into the zone above the bentonite seals to prevent water migration through the zone into the intake area of the piezometer. The fluctuation of groundwater table in response to rainfall was monitored and recorded every week.

(a) Piezometer transducer

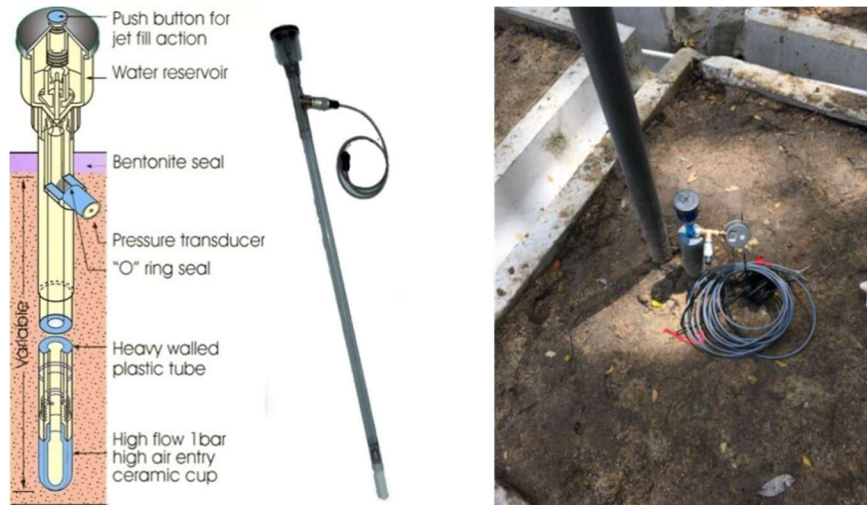
**Figure 31: Jet-fill tensiometer with transducer used in this study**

Four tensiometers were installed into the original slope and each GBS slopes to measure pore-water pressure change in response to rainfall infiltration. As shown in Figure 28, all tensiometers in original slopes were installed vertically from crest to a depth of 2 m. TM1 and TM2 of GBS slopes were also installed vertically from crest into compacted soil to a depth of 2 m while TM3 and TM4 were installed from the slope face to coarse and fine layers, respectively. The elevation of TM3 and TM4 from ground surface at crest were also 2 m. Prior to installation, the tensiometers were calibrated properly. Then, each jet-fill tensiometer was inserted inside the tube that has been provided during the construction of the GBS slopes until the tip of ceramic disc was embedded inside the soil. The jet-fill tensiometer (Figure 31) was supported with a bourdon gauge to verify the reading from transducer. The response of tensiometers to pore-water pressure change must be checked regularly to ensure the quality and physical performance of high air-entry ceramic tips. In this study, regular maintenance of the tensiometers was conducted twice a week by refilling the jet-fill reservoir with de-aired water and flushing the tensiometers to remove the accumulated or trapped air in the tensiometer tubes caused by cavitation of water and air diffusion through the ceramic tip.

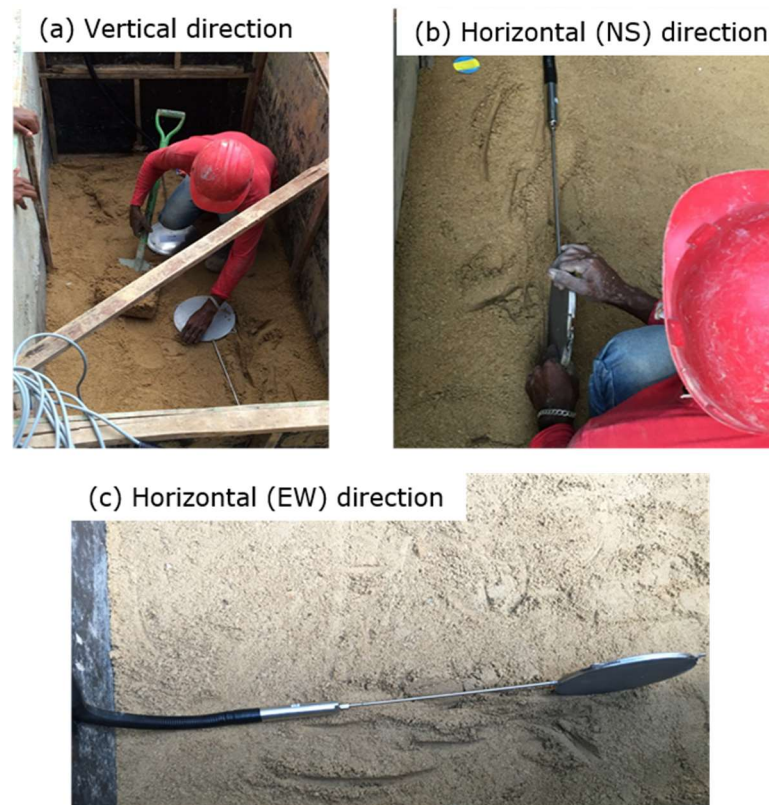
**Figure 33: Installation of Earth pressure cells in GBS slope 2**

Earth pressure cells were installed behind the original slope and GBS slope 2 to monitor the total vertical and lateral stresses changes due to rainwater infiltration in three directions  $z$  (i.e., vertical direction),  $x$  (i.e., east-west direction: perpendicular to the inclination of the slope) and  $y$  (i.e., north-south direction: parallel to the inclination of the slope). The installation of the earth pressure cells was carried out carefully to minimise soil disturbance due to the excavation of the slot for a pressure cell. [Figure 33](#) shows the earth pressure cells installed in GBS slope 2.

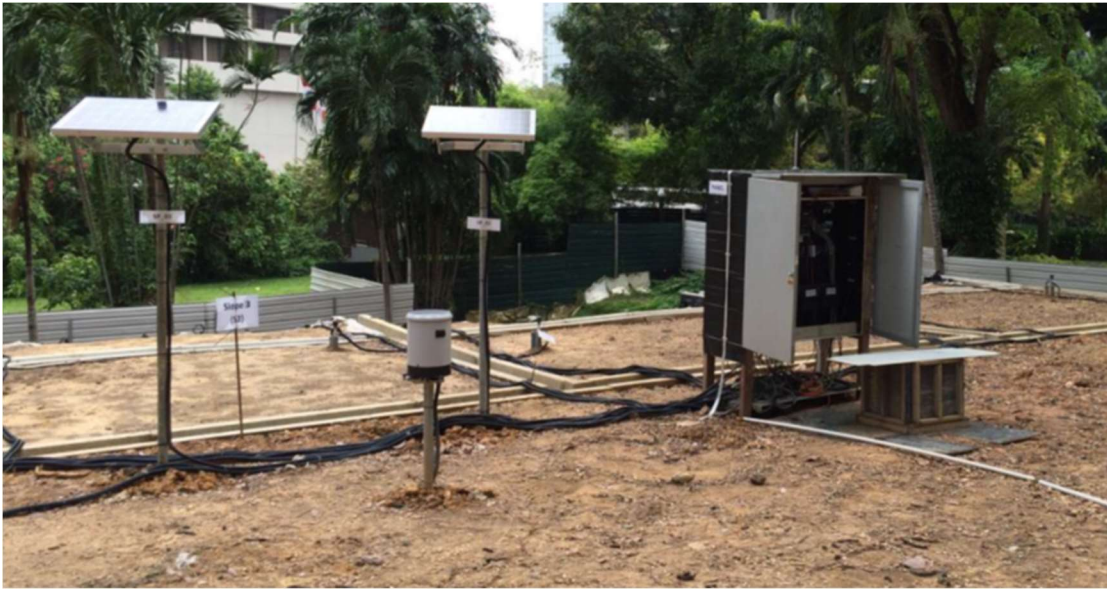
**Figure 35: Data acquisition system used at the study site**

The measuring instruments were calibrated in laboratory and checked on-site prior to installation, to obtain reliable readings. Readings of each instrument (tensiometers, soil moisture sensors, earth pressure cells, piezometers, rain-gauge) were checked before they were connected to a data acquisition system (DAS) to obtain instrumentation readings in real time. The data logger was powered by solar panel and battery. The cables were protected by corrugated tubing to prevent damages from rainfall and insects. The data logger recorded readings at a 10-minute interval regardless of rainfall events. [Figure 35](#) shows the data acquisition system used at the pilot study site at Orchard Boulevard.

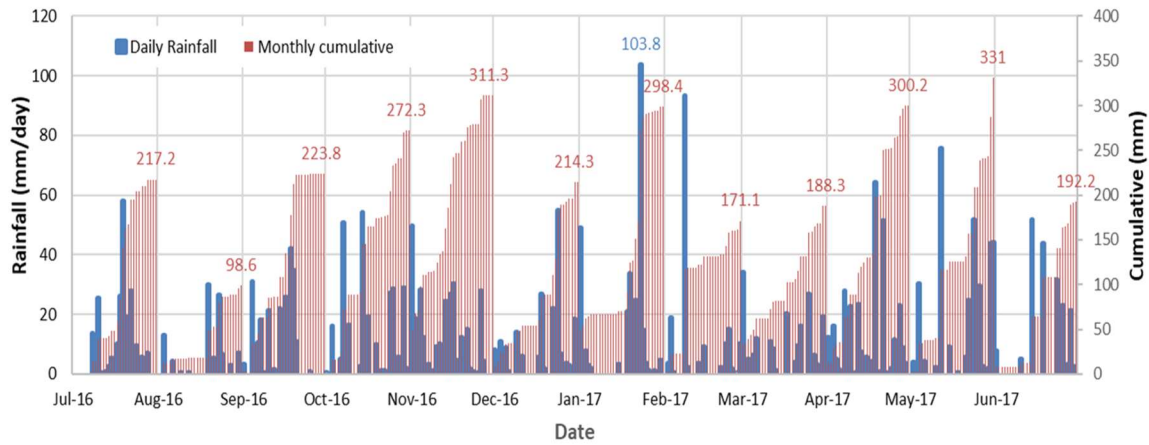
Figure 36: Daily and monthly cumulative rainfall from 1st July 2016 to June 2017

monthly rainfall in May 2017 (331 mm) was very high as compared to the average rainfall in Singapore for May (>200 mm). The monthly rainfall in September, October and November 2016 are higher than the average monthly rainfall for the months in Singapore. This inter-monsoon period in Singapore is usually wetter than March – May. Maximum daily rainfall occurred during the monsoon period in January 2017 i.e. 103.8 mm. The month of January 2017 started with a dry period for about two weeks but very wet period towards the end of the month. November 2016 was the wettest month during the monitoring period with cumulative rainfall of 311.3 mm rain and 21 rainfall days while August 2016 was the driest month with cumulative monthly rainfall of 98.6 mm. The highest cumulative rainfall occurred in May 2017 i.e. 331 mm with only 14 days of rainfall.

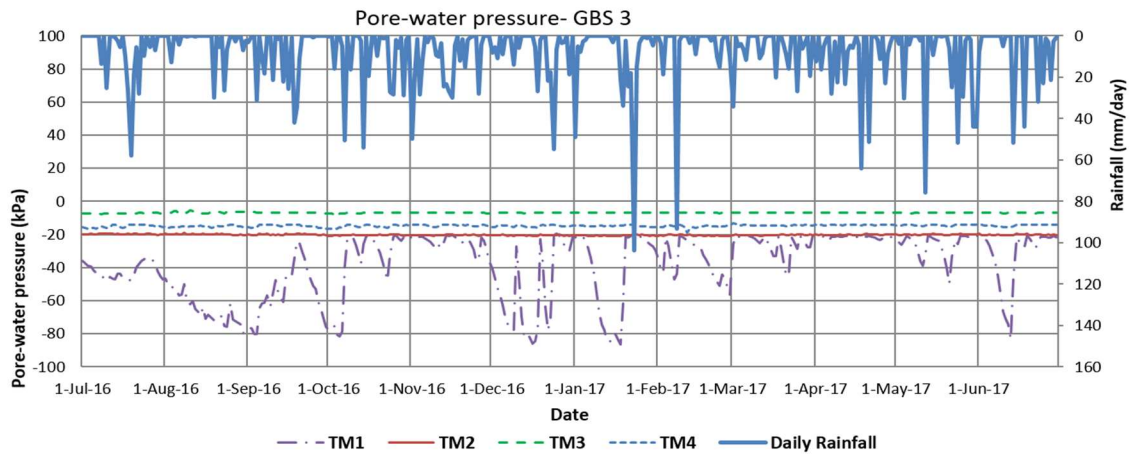
**Figure 39: Pore-water pressure readings in the GBS slopes at pilot study site**

As mentioned earlier, three GBS slopes and one section of the original slope were instrumented with tensiometers to observe the response of the slopes to rainfall infiltration in terms of pore-water pressure. Figure 39 shows the pore-water pressure response of GBS slopes to rainfall. The figure indicated that there was not much variation of pore-water pressure recorded in the GBS slope 2. The pore-water pressure recorded by TM1-GBS2 (2.1m from slope face) only varied between 15 and 25 kPa while TM2-GBS2 (1.1 m from slope face) recorded almost constant values. The pore-water pressure in Coarse RAP (TM3) was always constant with time while the readings from TM4 (fine grained layer) fluctuated slightly. On the other hand, the variation of pore-water pressure readings in TM2 of GBS slope 1 and TM1 of GBS slope 3 were quite significant. During long dry period, the pore water pressure could reach -80kPa but the reading recovered as soon as rain started to fall. This could be due to the effect of uneven compaction in the soil. Even-though the pore-water pressure in the compacted soil of GBS slopes 1 and 3 decreased to -80 kPa during dry periods, the pore-water pressure never increased to higher than -15 kPa during rainfall. This means that the change in the pore-water pressure was only due to the change in the moisture content of the soil and rainfall did not actually seeped into the compacted soil. The pore-water pressure readings of TM1 of GBS slopes 1 and TM2 of GBS slope 3 were similar with readings of TM1 and TM2 of GBS slope 2.

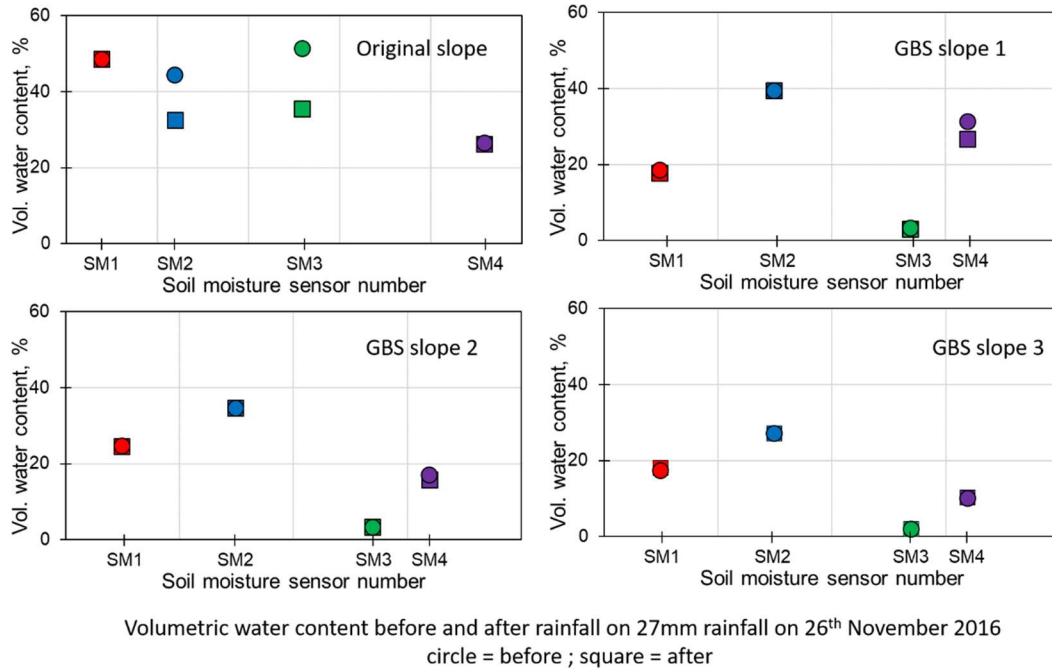
**Figure 44: PWP and VWC response of original slope and GBS slopes**

Figure 44 shows the response of volumetric water content to the individual rainfall on 26<sup>th</sup> November 2016. Similar with the pore-water pressure readings shown in Figure 41, the 27 mm rainfall induced changes in the volumetric water content readings in original slope. The effect of rainfall on the volumetric water content readings in the original slope was more than the effect on GBS slopes.

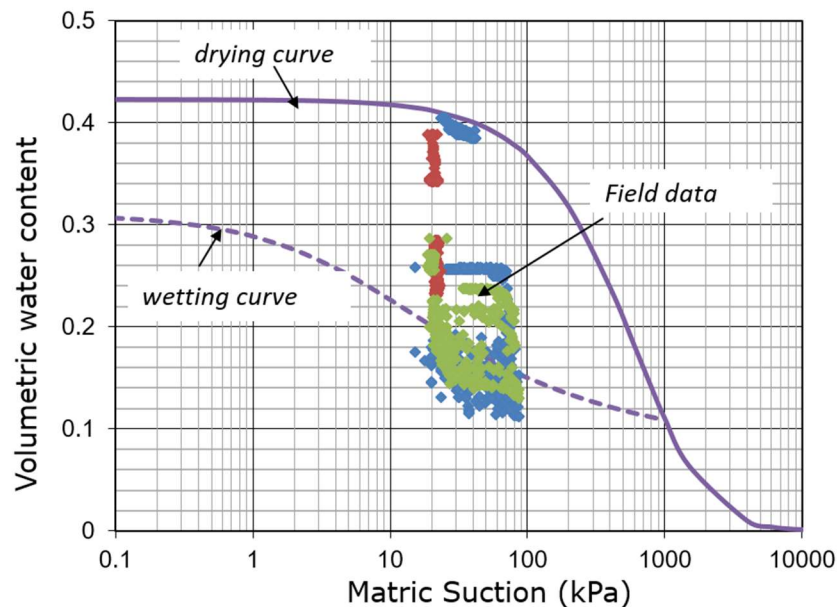
Figure 46: Plot of Field measurements in GBS slopes on SWCC of compacted soil

Figure 46 shows the plot of field data on compacted soil in GBS slopes 1, 2 and 3. This figure also shows that all field data fall within the hysteretic loop of drying and wetting curves of the compacted residual soil. The plot of field data in coarse and fine materials forming the capillary barrier of GBS slopes are shown in Figure 47 and 48. Most field data for coarse materials (RCA and RAP) are in the residual part of the SWCC. This is due to the condition of coarse RCA during construction was dry. Rainwater did not infiltrate into the coarse RCA, thus maintaining the dry or residual condition. The field data on fine materials (RCA and RAP) varied more significantly in terms of volumetric water content. For fine RCA, the data was concentrated in the transition zone of SWCC drying curve. Lower volumetric water contents were recorded in GBS slope 3. For fine RAP, the data concentrated toward the residual zone of SWCC due to the initial condition RAP.
