**LASER CLADDING RESEARCH FOR RAIL STEEL
REPAIR AND RELIABILITY ASSESSMENT**

SCHOOL OF MECHANICAL AND AEROSPACE ENGINEERING

2022

A thesis submitted to the Nanyang Technological University
in partial fulfilment of the requirement for the degree of
Doctor of Philosophy

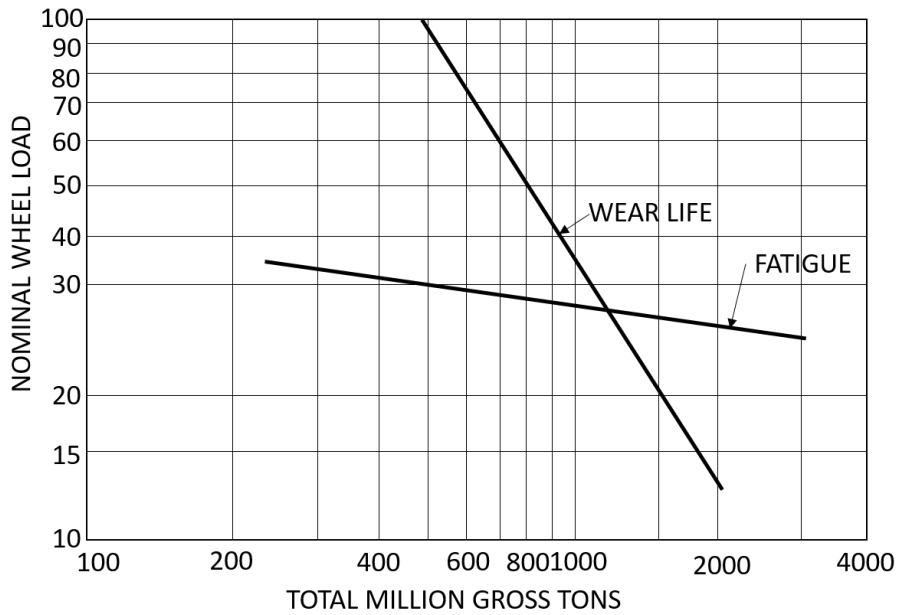
Zarembski derived the relationship between fatigue life and wear life for differing set of wheel loads as shown in Fig.2-23 [1]. Fatigue failure was observed to occur first for larger wheel loads and higher stresses whereas for lower axle loads and sharp curvature, failure due to wear is dominant.

Figure 2-23: Wear life vs fatigue life [1]

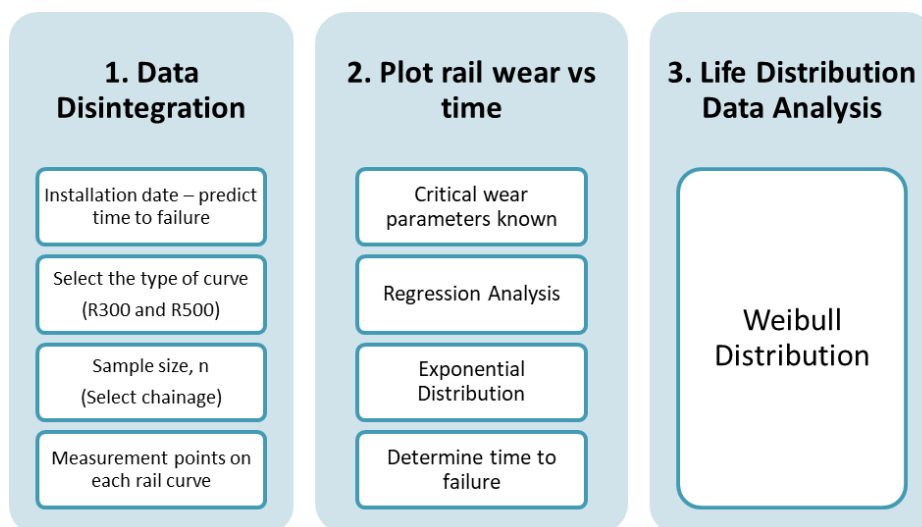
With the critical wear parameters known, the wear data is plot with respect to time and regression analysis is performed using to determine the time to failure. Statistical wear life data analysis is then performed using the 2-parameter Weibull distribution model. The framework of the method is shown in Fig.3-3 below.

Figure 3-3: Rail Wear Degradation Analysis Method Framework

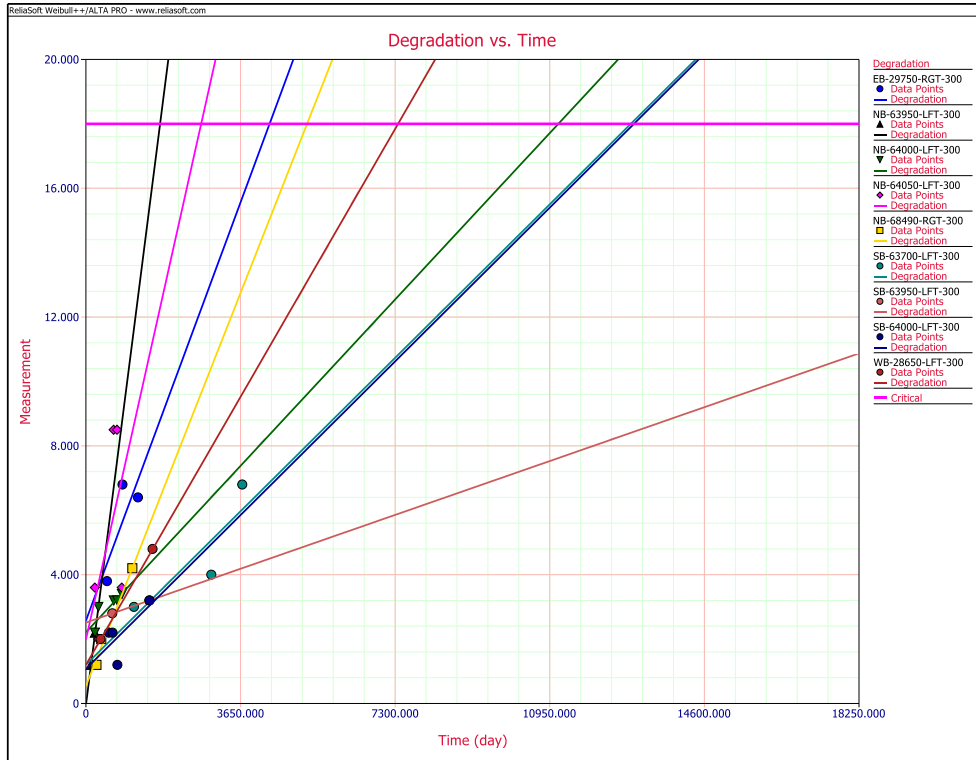
The time to failure data for R300 curve is obtained from the degradation vs time plots for failure analysis and prediction (Fig.3-6 and Fig.3-7). The graphs show the ‘fitting’ of the wear data based on the regression analysis performed. Similarly, the time to failure data for R500 curve is obtained from the degradation vs time plots for failure analysis and prediction (Fig.3-8 and Fig.3-9).

Figure 3-6: R300 Curve: High Rail Side Wear ($W_3 < 18$ mm)

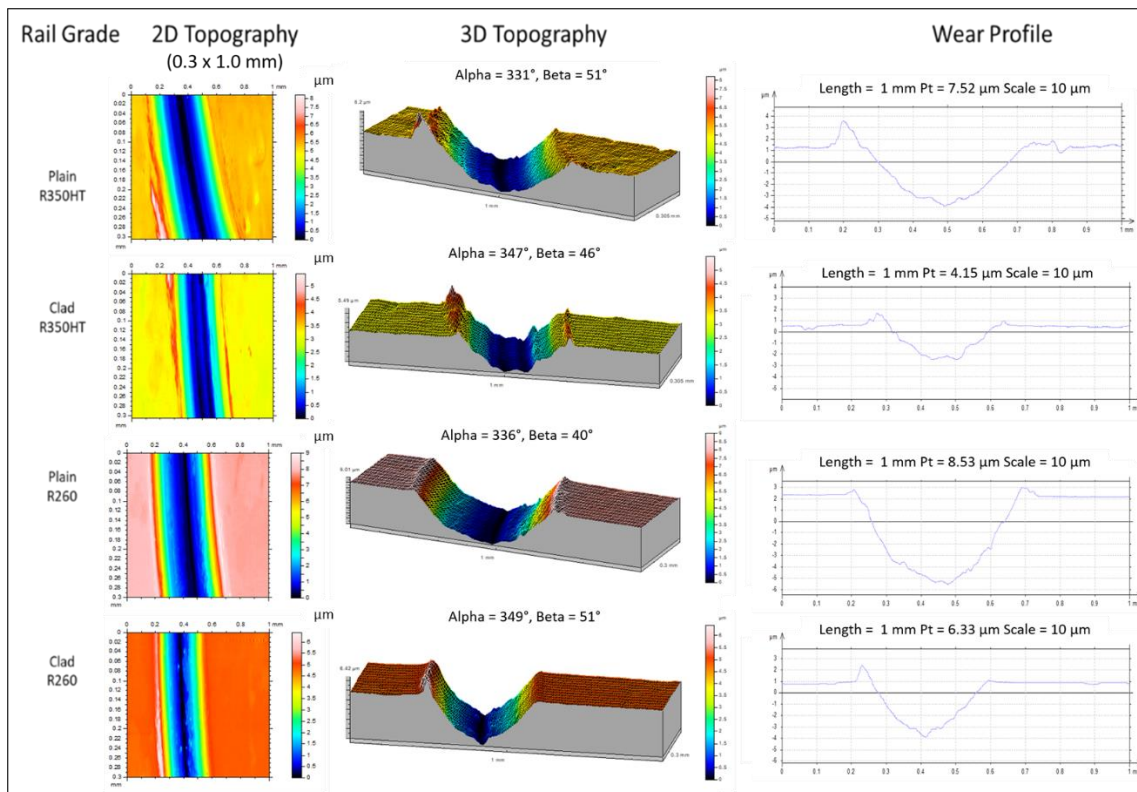
The Taylor Hobson surface profilometer was used to measure the wear scar depth by sliding a probe across the wear track. The surface topography in 2D and 3D along with the wear profile of the disc specimens are presented in Fig.5-5.

Figure 5-5: Surface topography and wear profile

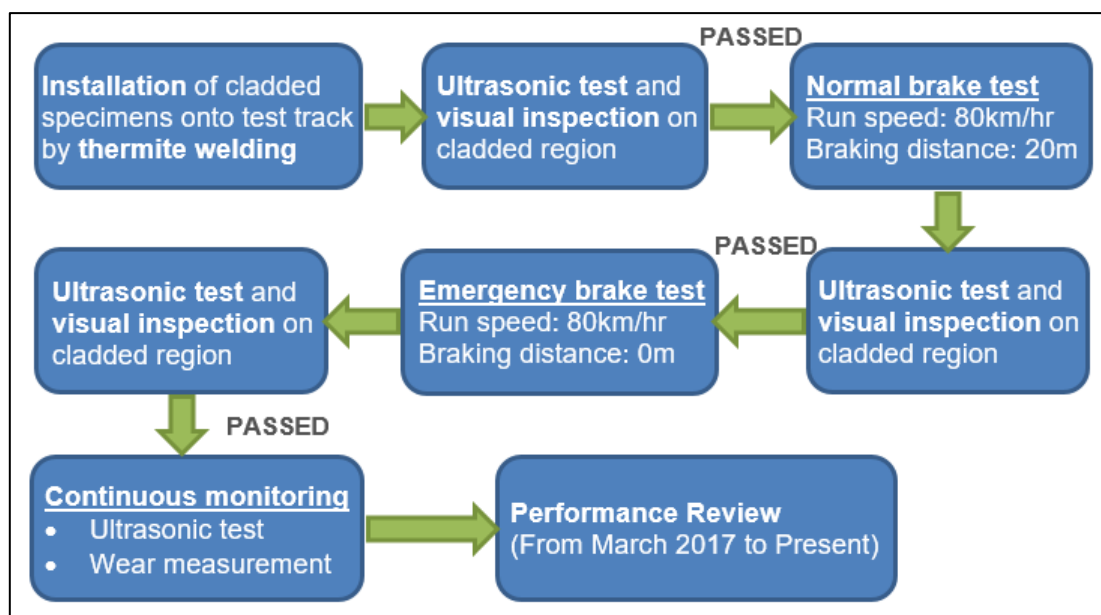
Figure 7-7: Reliability test flow of the full-scale cladded track trials

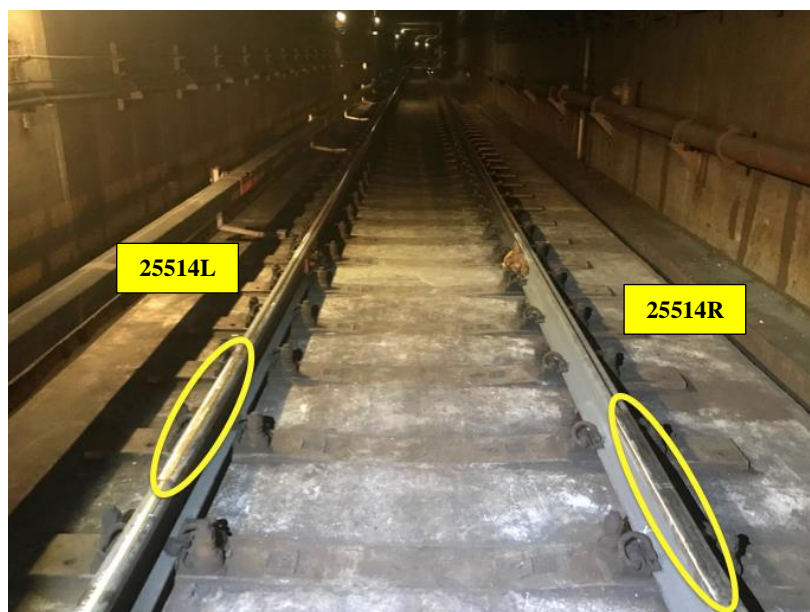
Figure 7-11: 2-clad rail specimens installed at Redhill-Tiong Bahru [CH 25514L & CH 25514R]

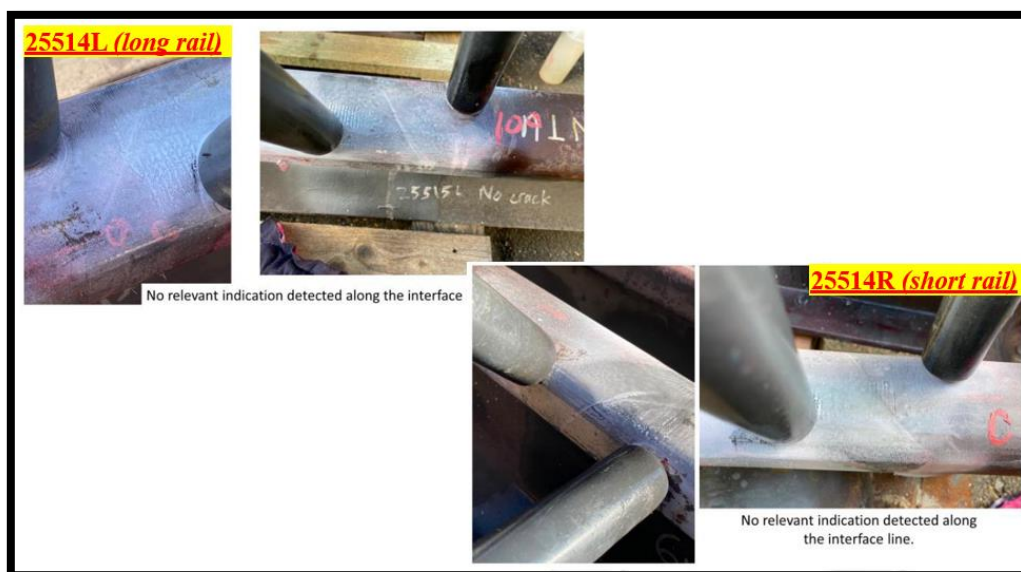
Figure 7-16: MPT Inspection results of extracted specimens 25514L & 25514R

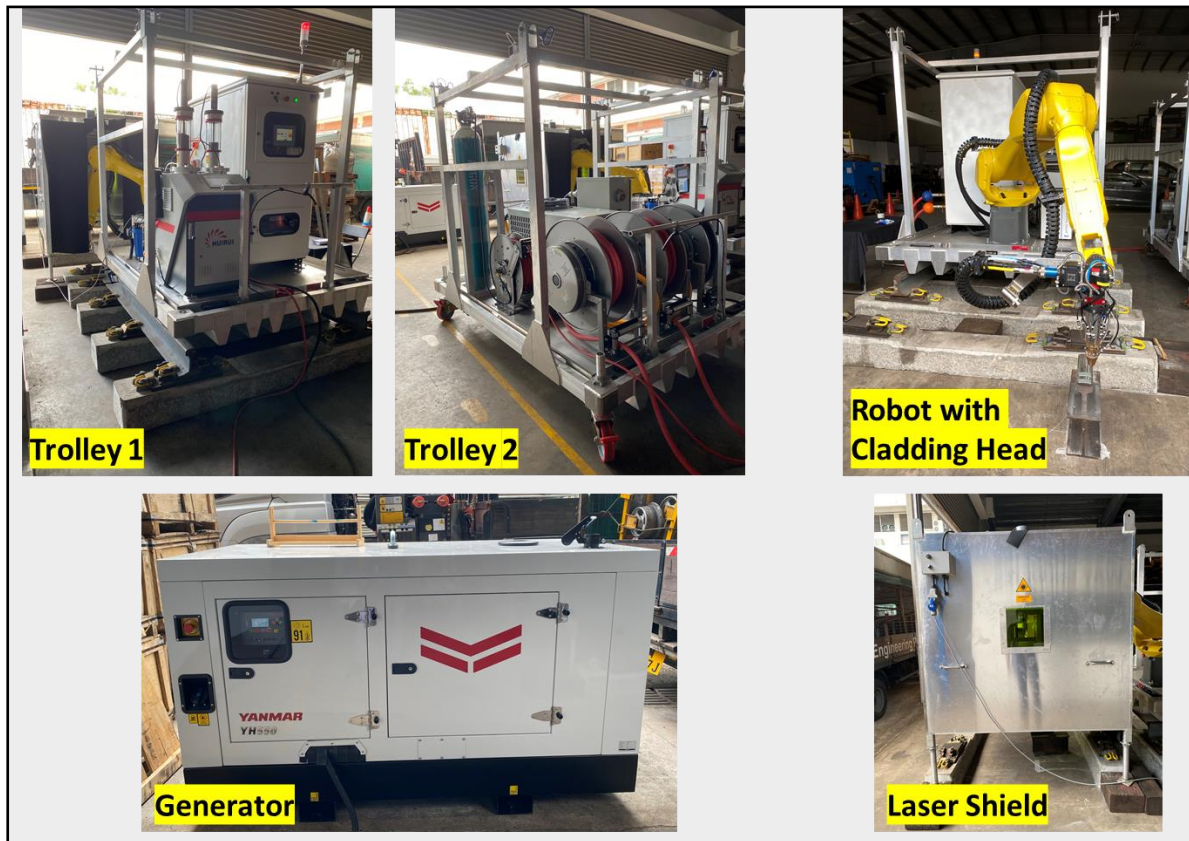
Figure 8-6: Complete setup of the portable laser cladding system
