# Damage Severity Prediction of Helicopter Windshields Caused by a Collision with a Small Unmanned Aerial Vehicle (sUAV)

Mohd Hasrizam Che Man<sup>1</sup>

Kin Huat Low<sup>2</sup>

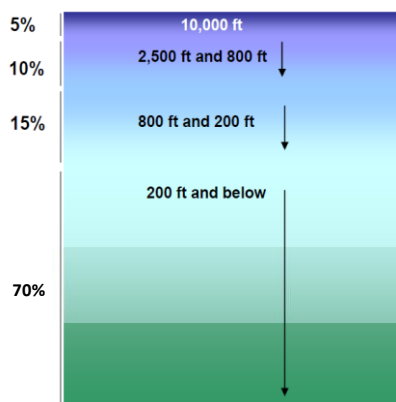
Fig. 1 Estimated percentage of bird strike per different altitude above ground level (AGL) [11, 17].

Commonly, helicopter is operating at the height of 400 ft susceptible to a high risk to strike with bird, data from Ilias [10] shows 70% of all bird strike cases reported occur within altitude less than 200 ft, and 95% of all strikes occur below 2500 ft, when considering worldwide traffic as shown Fig. 1. In addition, Dolbeer et. al [11] has concluded that 88% of all the bird strikes cases reported in the USA from 1990 until 2018 have occurred at altitude below 2500 ft and around 71% of the bird strike occurred below 500 ft as shown in Fig. 2. It can be concluded the highest probability of bird-aircraft collisions is at low altitudes [12]. It was also reported around 76% of cases reported involve bird strike with large birds, as shown in Fig. 3 [10]. Fig. 4 shows area of aircraft damaged from bird strike, and it is noted that around 13% of all cases is damage to the aircraft windshield and 30% of all the accidents to the windshield is damage involve helicopters [10].

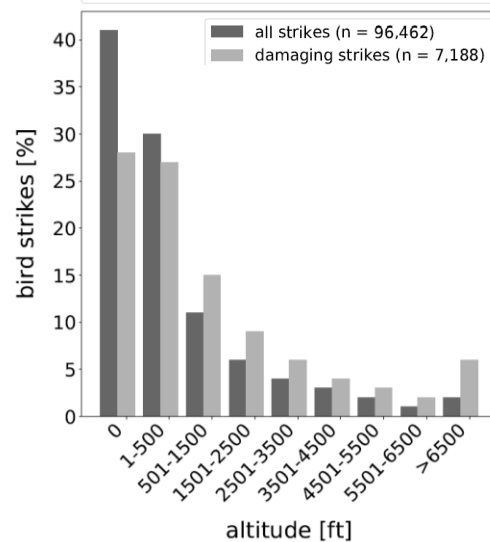
Fig. 2 Distribution of bird strikes by altitude (1990-2018) in the USA [17].

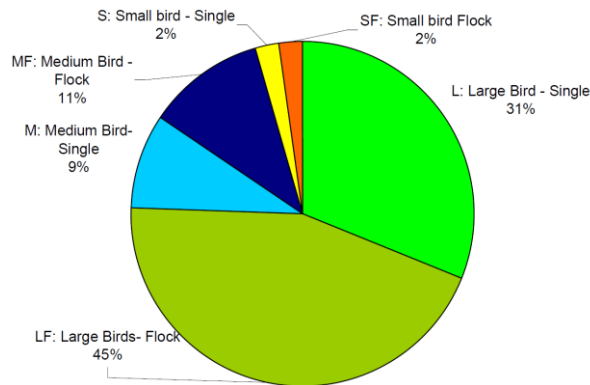
Fig. 3 Type of bird categories involved in helicopter bird strike incident reported worldwide (1998-2008) [10].

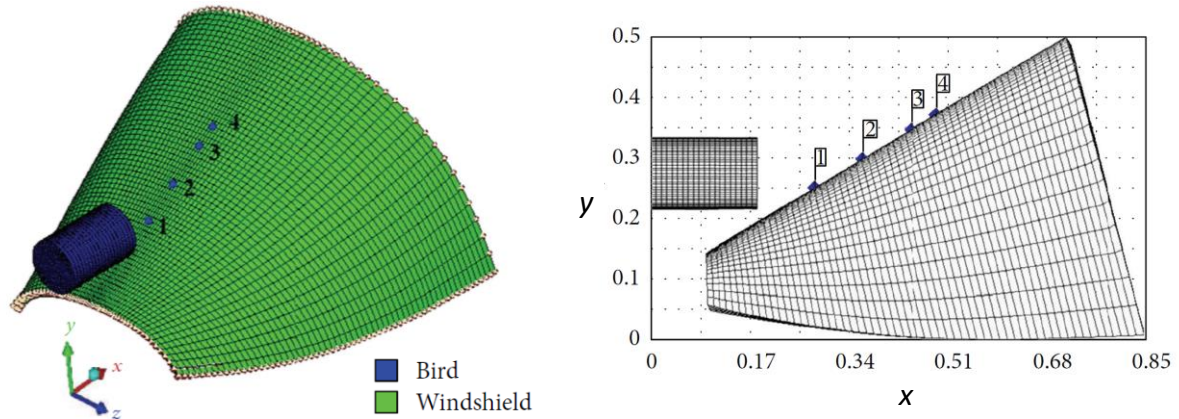
(a) Assembly of bird-windshield [24] (x-axis is the direction of the impactor projectile)

(b) Side view of the simulation assembly (1, 2, 3, 4 are the points of measurement taken)

Fig. 5 Finite element model of bird impact on windshield [24].

Fig. 5 shows the assembly of bird and aircraft windshield for the collision simulation by the finite element method (FEM). The FEM tool is adopted to perform Dynamic/Explicit simulation using ABAQUS in this study. The aircraft windshield is made out of acrylic and using the material data as tabulated in Table 1, with a thickness of 16 mm [22]. The aircraft windshield is meshed using quadrilateral with S4R element type with a total number of 15,400 elements. Here, the element sizes for the windshield are 6.0 mm.

The SPH model of a bird in this simulation that has 8190 nodes with each node has lumped mass with a weight of 0.1221 g and positioned at an average distance of 5.5 mm between two adjacent nodes. In the FEM collision simulations, the aircraft windshield is fixed in all three axes along the edges, with the bird impacted at an initial velocity of 64.4 m/s and 101.0 m/s as the experimental work done by Li et al. [23] and Shuhua et al. [22], respectively. In the experiment by [15], the displacement measurement is taken at four locations at the aircraft windshield, as shown in Fig. 5(a) and Fig. 5(b).
